## General Information

<b>Make</b>	Nissan	<b>Model</b>	Almera
<b>YOM</b>	2024	<b>Odo Meter Reading</b>	11,256
<b>Registration No.</b>	HAG7165	<b>Chassis No.</b>	MNTBAAN18Z0056158
<b>CC</b>	1.0	<b>Transmission</b>	CVT
<b>Fuel Type</b>	Gas	<b>Type of Body</b>	Sedan
<b>Colour</b>	Gray

## Body / Panel Condition

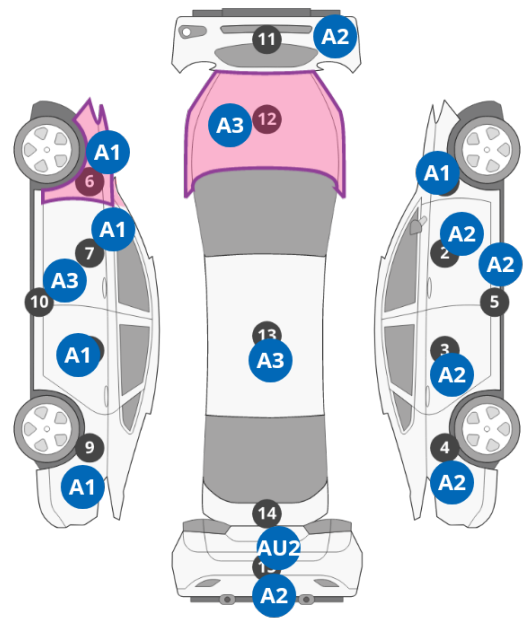
<p><b>A</b> : Scratch <b>AU</b> : Scratch &amp; Dent <b>B</b> : Modified <b>C</b> : Corrosion <b>G</b> : Stone chip <b>P</b> : Faded <b>S</b> : Rust <b>SC</b> : Rust &amp; Corrosion <b>U</b> : Dent <b>X</b> : Defective <b>Y</b> : Crack, Gap</p>
<p><b>Remarks</b> (R) Front Seat - Grime - Medium / (R) Front Trim - Grime - Small / Rear Seat - Grime - Small / (L) Front Trim - Grime - Small / (L) Front Seat - Grime - Small / Ceiling - Grime - Small</p>	<p><b>Remarks</b> (R) Front Fender - Repair Traces - Yes / Bonnet - Repair Traces - Yes / (L) Front Fender - Repair Traces - Yes / (L) Front Fender, Molding - Repair mark - Yes / Bonnet, Headlight - Repair mark - Yes / (L) Mirror - Scratch - Minimal / Bonnet, Headlight - Scratch - Medium / (L) Front Fender, Molding - Scratch - Minimal / Front Bumper, Grille, Lamps - Scratch - Small / (R) Front Fender, Molding - Scratch - Minimal / (R) Front Door, Molding - Scratch - Small / (R) Step, In-panel, Side Spoiler - Scratch - Small / (R) Rear Door, Molding - Scratch - Small / (R) Rear Fender, Molding - Scratch - Small / Roof - Scratch - Medium / Trunk Hood, Rear Gate - Scratch &amp; Dent - Small / Rear Bumper, Lamps, Panels - Scratch - Small / (L) Rear Fender, Molding - Scratch - Minimal / (L) Rear Door, Molding - Scratch - Minimal / (L) Front Door, Molding - Scratch - Medium</p>
