General Information

Date & Time: 13, Jan, 2026 15:21

Make	Suzuki	Model	Ertiga
YOM	2024	Odo Meter Reading	23,730
Registration No.	MNV1124	Chassis No.	MHYNC32S4RJ104605
CC	1.5	Transmission	A/T
Fuel Type	Hybrid	Type of Body	Wagon
Colour	Red

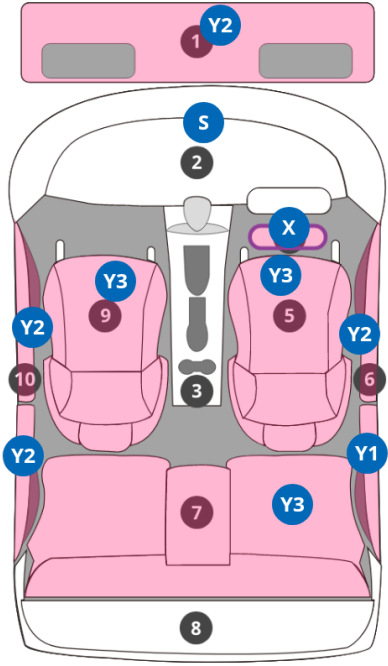
Interior Evaluation : C	Exterior Evaluation : E

<p>a : Cut, Fray d : Loose, Deformed k : Animal Hair s : Smell t : Cigarette Burns x : Defective y : Stain</p>

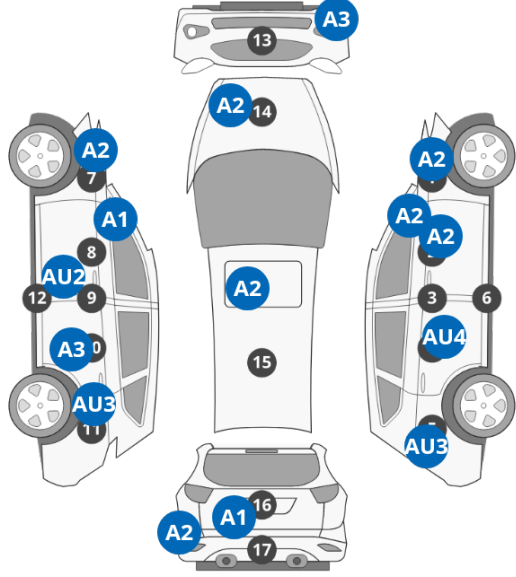
<p>A : Scratch AU : Scratch & Dent B : Modified C : Corrosion G : Stone chip P : Faded S : Rust SC : Rust & Corrosion U : Dent X : Defective Y : Crack, Gap</p>
<p>Remarks Rear Seat - Grime - Medium / (R) Front Seat - Grime - Medium / (L) Front Seat - Grime - Medium / Overall Interior - Smell - Yes / Mat Other - Missing - Yes / (R) Rear Trim - Grime - Minimal / (R) Front Trim - Grime - Small / (L) Front Trim - Grime - Small / (L) Rear Trim - Grime - Small / Ceiling - Grime - Small</p>	<p>Remarks (R) Front Fender, Molding - Scratch - Small / (R) Mirror - Scratch - Small / (R) Front Door, Molding - Scratch - Small / (R) Rear Fender, Molding - Scratch & Dent - Medium / (R) Rear Door, Molding - Scratch & Dent - Large / Rear Bumper, Lamps, Panels - Scratch - Small / Trunk Hood, Rear Gate - Scratch - Minimal / (L) Rear Fender, Molding - Scratch & Dent - Medium / (L) Front Door, Molding - Scratch & Dent - Small / (L) Rear Door, Molding - Scratch - Medium / (L) Mirror - Scratch - Minimal / (L) Front Fender, Molding - Scratch - Small / Front Bumper, Grille, Lamps - Scratch - Medium / Bonnet, Headlight - Scratch - Small / Roof - Scratch - Small</p>
