## General Information

<b>Make</b>	Mitsubishi	<b>Model</b>	L300
<b>YOM</b>	2025	<b>Odo Meter Reading</b>	13,338
<b>Registration No.</b>	NFM8900	<b>Chassis No.</b>	PAEL65MYSRB025169
<b>CC</b>	2.2	<b>Transmission</b>	M/T
<b>Fuel Type</b>	Diesel	<b>Type of Body</b>	FB Body
<b>Colour</b>	White

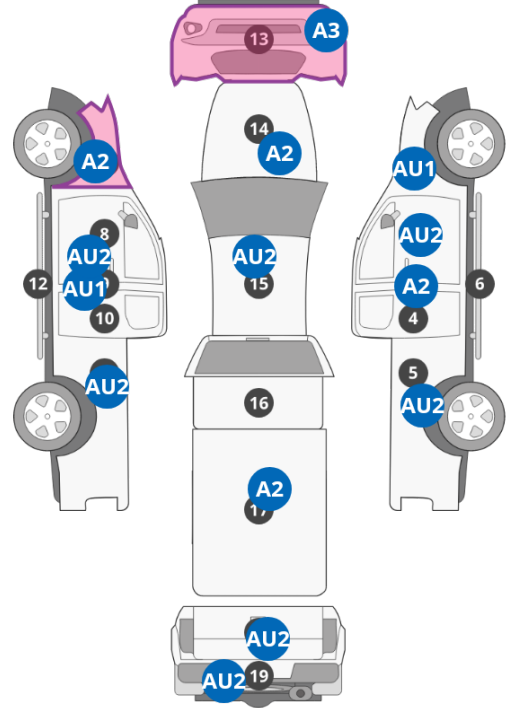
<p><b>A</b> : Scratch <b>AU</b> : Scratch &amp; Dent <b>B</b> : Modified <b>C</b> : Corrosion <b>G</b> : Stone chip <b>P</b> : Faded <b>S</b> : Rust <b>SC</b> : Rust &amp; Corrosion <b>U</b> : Dent <b>X</b> : Defective <b>Y</b> : Crack, Gap</p>
<p><b>Remarks</b> (L) Front Seat - Grime - Small / (R) Front Seat - Grime - Small / (L) Front Trim - Grime - Large / (R) Front Trim - Grime - Large / (R) Front Floor Mat - Grime - Small / (L) Front Floor Mat - Grime - Small / Rear Seat - Grime - Small / Sunvisor, Sunglass Holder - Grime - Large</p>	<p><b>Remarks</b> (R) Front Door, Molding - Scratch &amp; Dent - Small / (R) Center Panel - Scratch - Small / (R) Front Fender, Molding - Scratch &amp; Dent - Minimal / (L) Front Fender, Molding - Repair mark - Yes / Front Bumper, Grille, Lamps - Repair mark - Yes / (L) Front Fender, Molding - Scratch - Small / Front Bumper, Grille, Lamps - Scratch - Medium / (R) Side Gate - Scratch &amp; Dent - Small / Rear Bumper, Lamps, Panels - Scratch &amp; Dent - Small / Rear Gate - Scratch &amp; Dent - Small / (L) Side Gate - Scratch &amp; Dent - Small / Roof - Scratch &amp; Dent - Small / Cargo Bed Floor - Scratch - Small / (L) Center Panel - Scratch &amp; Dent - Minimal / (L) Front Door, Molding - Scratch &amp; Dent - Small / Front Panel - Scratch - Small</p>
