## General Information

Date & Time: 09, Jan, 2026 15:06

<b>Make</b>	MG	<b>Model</b>	MG 5
<b>YOM</b>	2024	<b>Odo Meter Reading</b>	2,531
<b>Registration No.</b>	NHU5914	<b>Chassis No.</b>	LSJA36E37RZ175581
<b>CC</b>	1.5	<b>Transmission</b>	CVT
<b>Fuel Type</b>	Gas	<b>Type of Body</b>	Sedan
<b>Colour</b>	Black

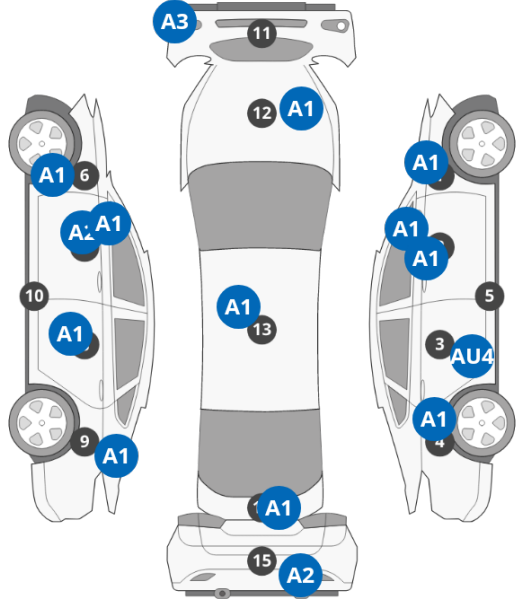
<p><b>A</b> : Scratch <b>AU</b> : Scratch &amp; Dent <b>B</b> : Modified <b>C</b> : Corrosion <b>G</b> : Stone chip <b>P</b> : Faded <b>S</b> : Rust <b>SC</b> : Rust &amp; Corrosion <b>U</b> : Dent <b>X</b> : Defective <b>Y</b> : Crack, Gap</p>
<p><b>Remarks</b> (R) Front Floor Mat - Worked - Small / (L) Front Floor Mat - Worked - Small / Ceiling - Grime - Small / Rear Seat - Grime - Minimal / (R) Front Seat - Grime - Small</p>	<p><b>Remarks</b> (R) Rear Door, Molding - Scratch &amp; Dent - Large / (R) Front Fender, Molding - Scratch - Minimal / (R) Mirror - Scratch - Minimal / (R) Front Door, Molding - Scratch - Minimal / (R) Rear Fender, Molding - Scratch - Minimal / Rear Bumper, Lamps, Panels - Scratch - Small / Trunk Hood, Rear Gate - Scratch - Minimal / (L) Rear Fender, Molding - Scratch - Minimal / (L) Rear Door, Molding - Scratch - Minimal / (L) Front Door, Molding - Scratch - Small / (L) Mirror - Scratch - Minimal / (L) Front Fender, Molding - Scratch - Minimal / Front Bumper, Grille, Lamps - Scratch - Medium / Bonnet, Headlight - Scratch - Minimal / Overall Exterior - Worn as per age - Yes / Roof - Scratch - Minimal</p>

<p><b>Inspector Notes</b></p>
<p>with warranty booklet, jack and tools, with spare tire, no LTO plate, scratches on tail light and headlight, reverse light issue,</p>
