General Information

Date & Time: 15, Jan, 2026 15:47

Make	Mitsubishi	Model	L300
YOM	2025	Odo Meter Reading	6,237
Registration No.	NKO2032	Chassis No.	PAEL65NUSRB000389
CC	2.2	Transmission	M/T
Fuel Type	Diesel	Type of Body	FB Body
Colour	White

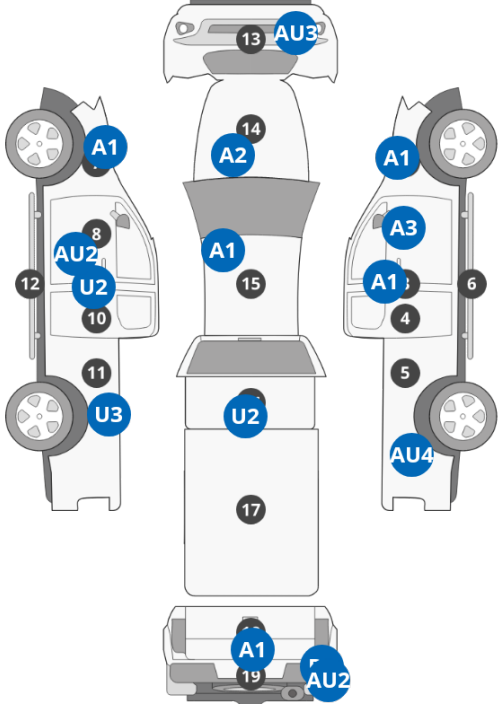
<p>A : Scratch AU : Scratch & Dent B : Modified C : Corrosion G : Stone chip P : Faded S : Rust SC : Rust & Corrosion U : Dent X : Defective Y : Crack, Gap</p>
<p>Remarks Sunvisor, Sunglass Holder - Grime - Medium / (L) Front Trim - Grime - Medium / (R) Front Trim - Grime - Medium / Ceiling - Grime - Minimal</p>	<p>Remarks (L) Rear Corner Panel - Repair Traces - Yes / (R) Rear Corner Panel - Repair Traces - Yes / (R) Front Fender, Molding - Scratch - Minimal / (R) Front Door, Molding - Scratch - Medium / (R) Center Panel - Scratch - Minimal / (R) Side Gate - Scratch & Dent - Large / Rear Bumper, Lamps, Panels - Modified - Small / Rear Gate - Scratch - Minimal / Cab Back Panel - Dent - Small / (L) Side Gate - Dent - Medium / (L) Center Panel - Dent - Small / (L) Front Door, Molding - Scratch & Dent - Small / (L) Front Fender, Molding - Scratch - Minimal / Front Bumper, Grille, Lamps - Scratch & Dent - Medium / Front Panel - Scratch - Small / Roof - Scratch - Minimal / Rear Bumper, Lamps, Panels - Scratch & Dent - Small</p>

<p>Inspector Notes</p>
<p>no warranty booklet, jack and tools, with spare tire, with LTO plate, scratches on tail light</p>
