General Information

Date & Time: 16, Dec, 2025 08:54

Make	Toyota	Model	Vios
YOM	2024	Odo Meter Reading	19,682
Registration No.	DBN3029	Chassis No.	PA1B18F39P4228396
CC	1.3	Transmission	CVT
Fuel Type	Gas	Type of Body	Sedan
Colour	Black

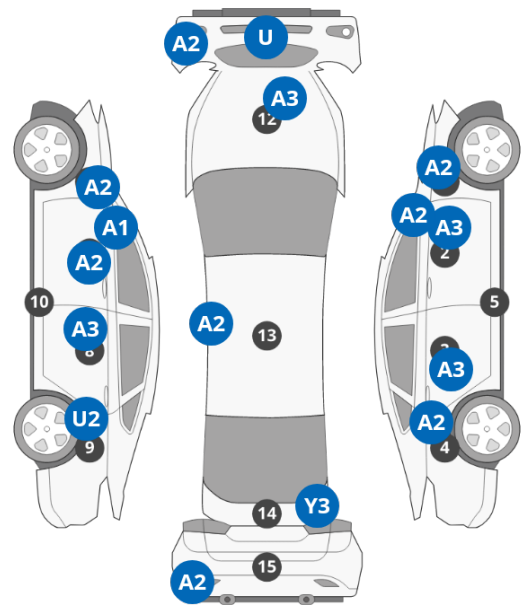
<p>A : Scratch AU : Scratch & Dent B : Modified C : Corrosion G : Stone chip P : Faded S : Rust SC : Rust & Corrosion U : Dent X : Defective Y : Crack, Gap</p>
<p>Remarks Overall Interior - Smell - Yes / Rear Seat - Grime - Small / (R) Front Seat - Grime - Medium / (L) Front Seat - Worn - Yes / Ceiling - Grime - Small / (L) Front Floor Mat - Cut, Crack - Small / (L) Front Floor Mat - Worked - Small / (L) Front Trim - Grime - Small / (R) Front Trim - Grime - Medium / (R) Rear Trim - Cut, Crack - Small</p>	<p>Remarks (L) Rear Fender - Repair Traces - Yes / Trunk Hood, Rear Gate - Repair Traces - Yes / Member (Bolted) - Dent - Yes / (R) Front Fender, Molding - Scratch - Small / (R) Front Door, Molding - Scratch - Medium / (R) Rear Door, Molding - Scratch - Medium / (R) Rear Fender, Molding - Scratch - Small / Rear Bumper, Lamps, Panels - Scratch - Small / (L) Rear Fender, Molding - Dent - Small / (L) Rear Door, Molding - Scratch - Medium / (L) Front Door, Molding - Scratch - Small / (L) Mirror - Scratch - Minimal / (L) Front Fender, Molding - Scratch - Small / Front Bumper, Grille, Lamps - Scratch - Small / Bonnet, Headlight - Scratch - Medium / (R) Mirror - Scratch - Small / Roof - Scratch - Small / Trunk Hood, Rear Gate - Crack, Gap - Medium</p>
