## General Information

<b>Make</b>	Suzuki	<b>Model</b>	S-Presso
<b>YOM</b>	2024	<b>Odo Meter Reading</b>	21,955
<b>Registration No.</b>	GBF1659	<b>Chassis No.</b>	MA3FL61SORA466844
<b>CC</b>	1.0	<b>Transmission</b>	A/T
<b>Fuel Type</b>	Gas	<b>Type of Body</b>	Hatchback
<b>Colour</b>	Gray

## Body / Panel Condition

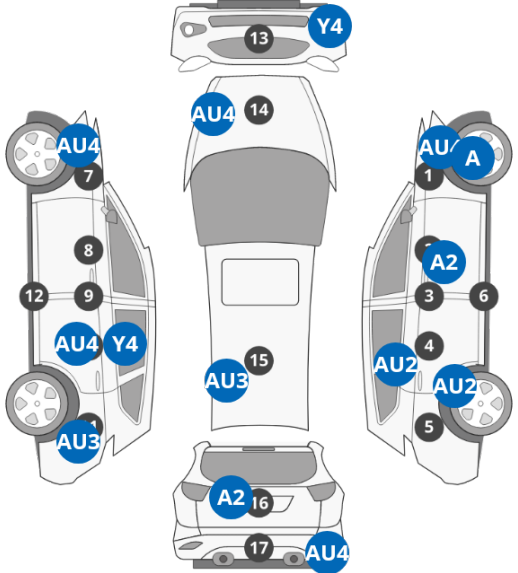
</div> <p><b>A</b> : Scratch <b>AU</b> : Scratch &amp; Dent <b>B</b> : Modified <b>C</b> : Corrosion <b>G</b> : Stone chip <b>P</b> : Faded <b>S</b> : Rust <b>SC</b> : Rust &amp; Corrosion <b>U</b> : Dent <b>X</b> : Defective <b>Y</b> : Crack, Gap</p>
<p><b>Remarks</b> Ceiling - Grime - Medium / (L) Front Trim - Grime - Small / (R) Front Trim - Grime - Small / (R) Rear Trim - Grime - Small / (L) Rear Trim - Grime - Small / Dashboard - Worked - Large / Steering Wheel - Worn, Peel, Crack - Large</p>	<p><b>Remarks</b> Roof - Repair Traces - Yes / (R) Front Fender, Molding - Scratch &amp; Dent - Large / Front Bumper, Grille, Lamps - Crack, Gap - Large / Bonnet, Headlight - Scratch &amp; Dent - Large / (L) Front Fender, Molding - Scratch &amp; Dent - Large / (L) Rear Door, Molding - Scratch &amp; Dent - Large / (L) Side Window - Damaged - Large / Rear Bumper, Lamps, Panels - Scratch &amp; Dent - Large / (R) Front Door, Molding - Scratch - Small / (R) Rear Fender, Molding - Scratch &amp; Dent - Small / (L) Rear Fender, Molding - Scratch &amp; Dent - Medium / Roof - Scratch &amp; Dent - Medium / Trunk Hood, Rear Gate - Scratch - Small / (R) Rear Door, Molding - Scratch &amp; Dent - Small / (R) Front Tyre - Crack, Cut - Yes</p>
