## General Information

Date & Time: 16, Dec, 2025 13:14

<b>Make</b>	Toyota	<b>Model</b>	Vios
<b>YOM</b>	2024	<b>Odo Meter Reading</b>	40,795
<b>Registration No.</b>	NIT9414	<b>Chassis No.</b>	PA1B18F34P4229505
<b>CC</b>	1.3	<b>Transmission</b>	CVT
<b>Fuel Type</b>	Gas	<b>Type of Body</b>	Sedan
<b>Colour</b>	Blue

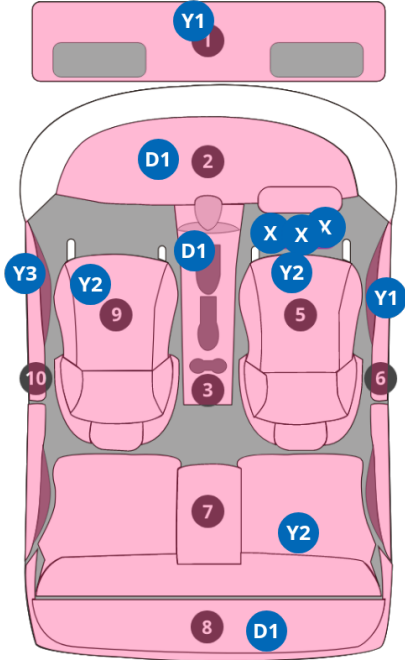
<b>Interior Evaluation :</b> <span style="float: right;"><b>B</b></span>	<b>Exterior Evaluation :</b> <span style="float: right;"><b>D</b></span>

<p><b>a</b> : Cut, Fray <b>d</b> : Loose, Deformed <b>k</b> : Animal Hair <b>s</b> : Smell <b>t</b> : Cigarette Burns <b>x</b> : Defective <b>y</b> : Stain</p>

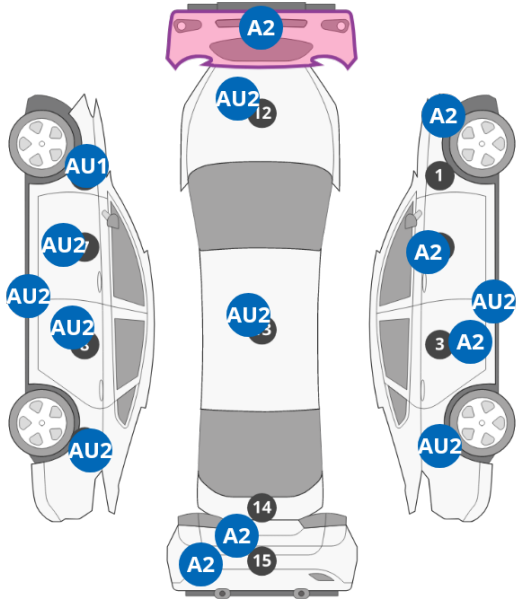
<p><b>A</b> : Scratch <b>AU</b> : Scratch &amp; Dent <b>B</b> : Modified <b>C</b> : Corrosion <b>G</b> : Stone chip <b>P</b> : Faded <b>S</b> : Rust <b>SC</b> : Rust &amp; Corrosion <b>U</b> : Dent <b>X</b> : Defective <b>Y</b> : Crack, Gap</p>
<p><b>Remarks</b> Mat Other - Missing - Yes / (R) Front Floor Mat - Missing - Yes / (L) Front Floor Mat - Missing - Yes / Ceiling - Grime - Minimal / (L) Front Seat - Grime - Small / (R) Front Seat - Grime - Small / (L) Front Trim - Grime - Medium / (R) Front Trim - Grime - Minimal / Console, Switches, Vents - Worked - Minimal / Rear Seat - Grime - Small / Trunk Room - Worked - Minimal / Dashboard - Worked - Minimal</p>	<p><b>Remarks</b> Roof - Repair Traces - Yes / Trunk Hood, Rear Gate - Scratch - Small / Rear Bumper, Lamps, Panels - Scratch - Small / (R) Rear Fender, Molding - Scratch &amp; Dent - Small / (R) Rear Door, Molding - Scratch - Small / (R) Front Door, Molding - Scratch - Small / (R) Step, In-panel, Side Spoiler - Scratch &amp; Dent - Small / (R) Front Fender, Molding - Scratch - Small / Bonnet, Headlight - Scratch &amp; Dent - Small / (L) Front Fender, Molding - Scratch &amp; Dent - Minimal / (L) Front Door, Molding - Scratch &amp; Dent - Small / (L) Step, In-panel, Side Spoiler - Scratch &amp; Dent - Small / (L) Rear Door, Molding - Scratch &amp; Dent - Small / (L) Rear Fender, Molding - Scratch &amp; Dent - Small / Roof - Scratch &amp; Dent - Small / Front Bumper, Grille, Lamps - Scratch - Small / Front Bumper, Grille, Lamps - Repair mark - Yes</p>
