## General Information

| Make | Toyota | Model | Vios |
| Registration No. | NFH4759 | Chassis No. | PA1B18F32N4172850 |

## Body / Panel Condition

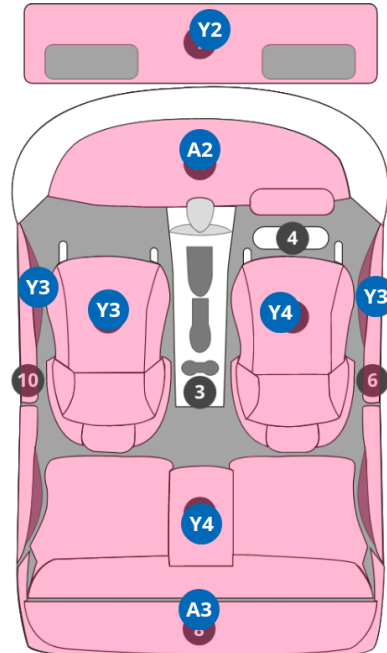
| <div> <div>Remarks</div> <div>(R) Front Seat - Grime - Large / (R) Front Trim - Grime - Medium / Rear Seat - Grime - Large / Trunk Room - Worn, Scratch, Cut, Crack - Medium / (L) Front Trim - Grime - Medium / (L) Front Seat - Grime - Medium / Ceiling - Grime - Small / Dashboard - Worn, Scratch, Cut, Crack - Small</div> </div> | <div> <div>Remarks</div> <div>(R) Front Door - Repair Traces - Yes / (R) Front Fender - Repair Traces - Yes / Bonnet - Repair Traces - Yes / (L) Front Fender - Repair Traces - Yes / (L) Front Door - Repair Traces - Yes / (L) Rear Door - Repair Traces - Yes / (L) Rear Fender - Repair Traces - Yes / Trunk Hood, Rear Gate - Repair Traces - Yes / (R) Rear Fender - Repair Traces - Yes / (R) Rear Door - Repair Traces - Yes / Roof - Repair Traces - Yes / Bonnet, Headlight - Scratch &amp; Dent - Large / Front Bumper, Grille, Lamps - Scratch - Large / (L) Front Fender, Molding - Scratch &amp; Dent - Large / (L) Front Fender, Molding - Repair mark - Yes / (L) Rear Fender, Molding - Repair mark - Yes / (R) Front Fender, Molding - Repair mark - Yes / Member (Bolted) - Dent - Yes / (L) Mirror - Scratch - Medium / (L) Step, In-panel, Side Spoiler - Dent - Small / (L) Front Door, Molding - Scratch - Medium / (L) Rear Door, Molding - Scratch - Medium / (L) Rear Fender, Molding - Scratch - Medium / Rear Bumper, Lamps, Panels - Scratch - Large / Trunk Hood, Rear Gate - Scratch &amp; Dent - Medium / (R) Rear Fender, Molding - Scratch - Small / (R) Rear Door, Molding - Scratch - Large / (R) Step, In-panel, Side Spoiler - Dent - Medium / (R) Front Door, Molding - Scratch - Medium / (R) Front Fender, Molding - Scratch &amp; Dent - Small / Roof - Dent - Small / (L) Front Wheel, Cover - Scratch, Corrosion - Small / (R) Rear Wheel, Cover - Scratch, Corrosion - Small / (L) Rear Wheel, Cover - Scratch, Corrosion - Small / (R) Front Wheel, Cover - Scratch, Corrosion - Small</div> </div> |
