General Information

Make	Toyota	Model	Avanza
YOM	2023	Odo Meter Reading	53,720
Registration No.	NFC9365-1	Chassis No.	MHFA1BYXP0016800
CC	1.3	Transmission	M/T
Fuel Type	Gas	Type of Body	MPV
Colour	Red Mica Metallic

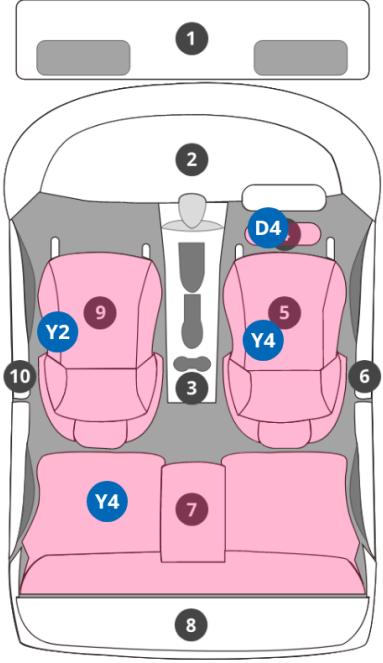
Interior Evaluation : C	Exterior Evaluation : E

<p>a : Cut, Fray d : Loose, Deformed k : Animal Hair s : Smell t : Cigarette Burns x : Defective y : Stain</p>

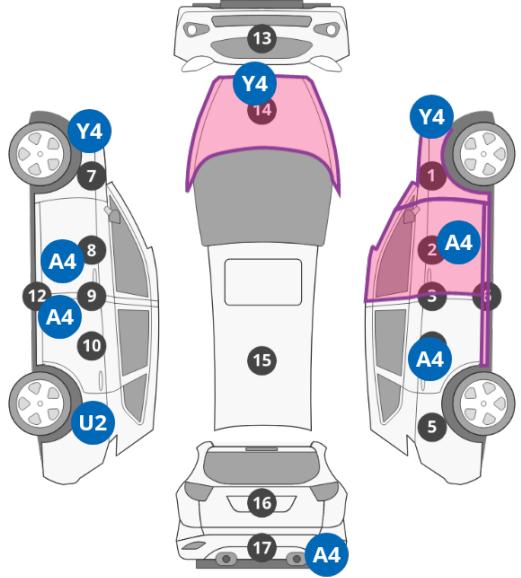
<p>A : Scratch AU : Scratch & Dent B : Modified C : Corrosion G : Stone chip P : Faded S : Rust SC : Rust & Corrosion U : Dent X : Defective Y : Crack, Gap</p>
<p>Remarks (L) Front Floor Mat - Worked - Large / (R) Front Seat - Grime - Large / (L) Front Seat - Grime - Small / Rear Seat - Grime - Large</p>	<p>Remarks (R) Front Door - Repair Traces - Yes / (R) Step - Repair Traces - Yes / (R) Step - Replaced - Yes / (R) Front Fender - Repair Traces - Yes / Bonnet - Repair Traces - Yes / (L) Front Fender - Repair Traces - Yes / Bonnet, Headlight - Repair mark - Yes / (R) Front Fender, Molding - Crack, Gap - Large / (L) Front Fender, Molding - Crack, Gap - Large / Bonnet, Headlight - Crack, Gap - Large / (L) Rear Fender, Molding - Dent - Small / Rear Bumper, Lamps, Panels - Scratch - Large / (R) Rear Door, Molding - Scratch - Large / (R) Front Door, Molding - Scratch - Large / (R) Front Fender, Molding - Repair mark - Yes / (R) Front Door, Molding - Repair mark - Yes / (L) Front Door, Molding - Scratch - Large / (L) Rear Door, Molding - Scratch - Large</p>
