General Information

| Make | Toyota | Model | Vios |
| Registration No. | DBP6209 | Chassis No. | PA1B18F3XR4264116 |

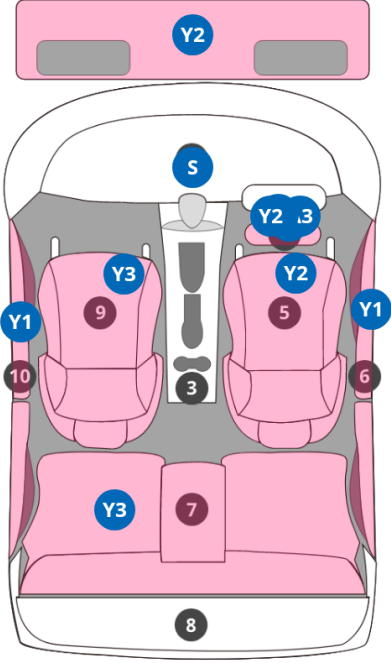
| Interior Evaluation : C | Exterior Evaluation : E |
| <p>Remarks (L) Front Seat - Grime - Medium / (L) Front Floor Mat - Worked - Large / (L) Front Floor Mat - Cut, Crack - Medium / Overall Interior - Smell - Yes / (R) Front Seat - Grime - Small / Mat Other - Grime - Small / Rear Seat - Grime - Medium / Ceiling - Grime - Small / (L) Front Trim - Grime - Minimal / (R) Front Floor Mat - Grime - Small / (R) Front Trim - Grime - Minimal</p> | <p>Remarks (R) Front Fender, Molding - Repair mark - Yes / (R) Front Fender, Molding - Scratch & Dent - Large / (R) Mirror - Scratch - Small / Front Bumper, Grille, Lamps - Modified - Minimal / Front Bumper, Grille, Lamps - Repair mark - Yes / (R) Rear Door, Molding - Scratch - Small / (R) Front Door, Molding - Scratch - Medium / (R) Rear Fender, Molding - Scratch - Small / Rear Bumper, Lamps, Panels - Repair mark - Yes / Rear Bumper, Lamps, Panels - Scratch - Medium / (L) Rear Fender, Molding - Scratch - Small / (L) Rear Door, Molding - Scratch - Small / (L) Front Door, Molding - Scratch - Small / (L) Mirror - Crack - Damaged / (L) Front Fender, Molding - Repair mark - Yes / (L) Front Fender, Molding - Scratch & Dent - Medium / Front Bumper, Grille, Lamps - Scratch & Dent - Large / Member (Bolted) - Dent - Yes / Bonnet, Headlight - Crack, Gap - Large / Roof - Scratch - Small / Trunk Hood, Rear Gate - Crack, Gap - Medium</p> |

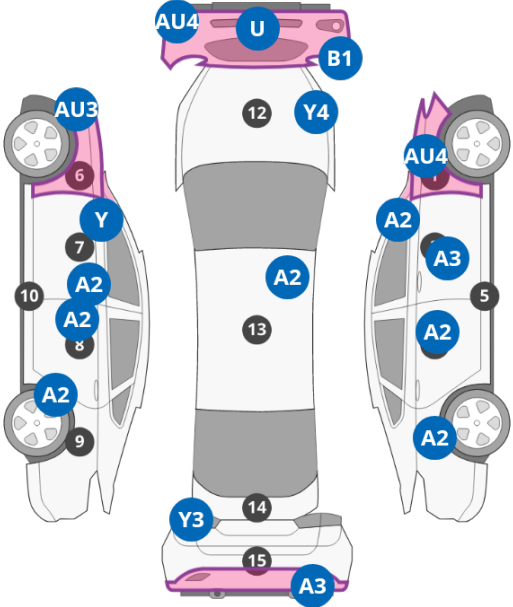
| <p>with warranty booklet, with jack, incomplete tools, with spare tire, with LTO plate, scratched and cracked tail light, left side mirror cover/housing missing</p> |
