## General Information

<b>Make</b>	Toyota	<b>Model</b>	Vios
<b>YOM</b>	2025	<b>Odo Meter Reading</b>	32,626
<b>Registration No.</b>	DBP3742	<b>Chassis No.</b>	PA1B18F32R4262716
<b>CC</b>	1.3	<b>Transmission</b>	CVT
<b>Fuel Type</b>	Gas	<b>Type of Body</b>	Sedan
<b>Colour</b>	Black

## Body / Panel Condition

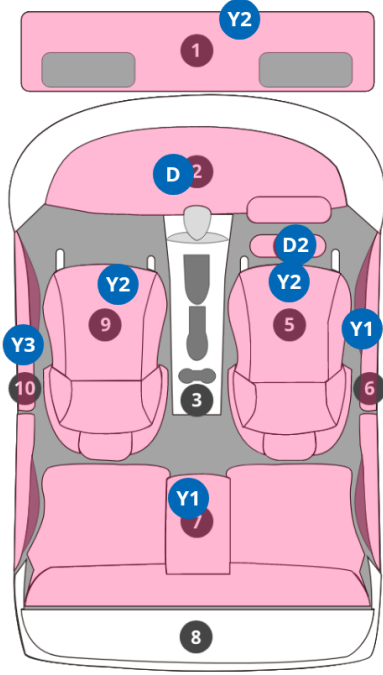
<b>Interior Evaluation :</b> <span style="float: right; color: red; font-weight: bold;">B</span>	<b>Exterior Evaluation :</b> <span style="float: right; color: red; font-weight: bold;">C</span>

<p><b>a</b> : Cut, Fray <b>d</b> : Loose, Deformed <b>k</b> : Animal Hair <b>s</b> : Smell <b>t</b> : Cigarette Burns <b>x</b> : Defective <b>y</b> : Stain</p>

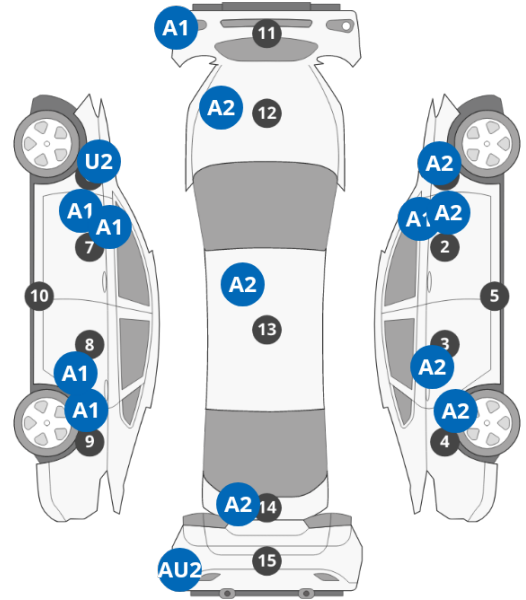
<p><b>A</b> : Scratch <b>AU</b> : Scratch &amp; Dent <b>B</b> : Modified <b>C</b> : Corrosion <b>G</b> : Stone chip <b>P</b> : Faded <b>S</b> : Rust <b>SC</b> : Rust &amp; Corrosion <b>U</b> : Dent <b>X</b> : Defective <b>Y</b> : Crack, Gap</p>
<p><b>Remarks</b> (L) Front Trim - Grime - Medium / (L) Front Floor Mat - Worked - Small / (R) Front Seat - Grime - Small / (L) Front Seat - Grime - Small / Ceiling - Grime - Small / Rear Seat - Grime - Minimal / Dashboard - Traces of Adhesive Tape - Yes / (R) Front Trim - Grime - Minimal</p>	<p><b>Remarks</b> (R) Front Fender, Molding - Scratch - Small / (R) Mirror - Scratch - Minimal / (R) Front Door, Molding - Scratch - Small / (R) Rear Fender, Molding - Scratch - Small / (R) Rear Door, Molding - Scratch - Small / Rear Bumper, Lamps, Panels - Scratch &amp; Dent - Small / Trunk Hood, Rear Gate - Scratch - Small / (L) Rear Fender, Molding - Scratch - Minimal / (L) Rear Door, Molding - Scratch - Minimal / (L) Front Door, Molding - Scratch - Minimal / (L) Mirror - Scratch - Minimal / (L) Front Fender, Molding - Dent - Small / Front Bumper, Grille, Lamps - Scratch - Minimal / Bonnet, Headlight - Scratch - Small / Roof - Scratch - Small</p>
