General Information

Make	Toyota	Model	Vios
YOM	2025	Odo Meter Reading	16,137
Registration No.	NHS9416	Chassis No.	PA1B18F36R4270706
CC	1.3	Transmission	CVT
Fuel Type	Gas	Type of Body	Sedan
Colour	Red Mica Metallic

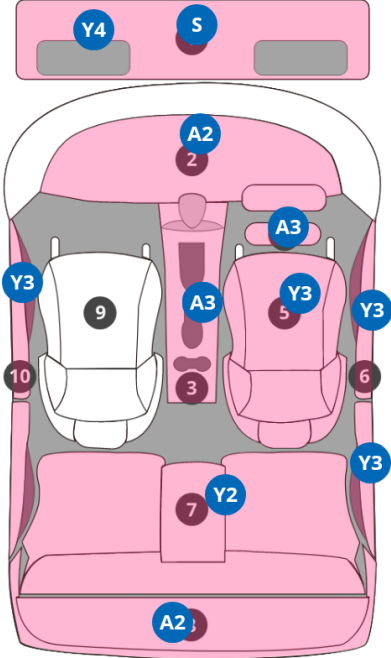
<p>a : Cut, Fray d : Loose, Deformed k : Animal Hair s : Smell t : Cigarette Burns x : Defective y : Stain</p>

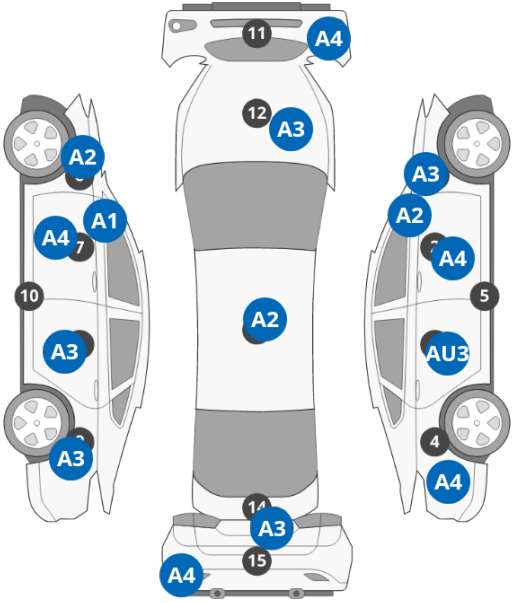
<p>A : Scratch AU : Scratch & Dent B : Modified C : Corrosion G : Stone chip P : Faded S : Rust SC : Rust & Corrosion U : Dent X : Defective Y : Crack, Gap</p>
<p>Remarks (R) Front Seat - Grime - Medium / (R) Front Trim - Grime - Medium / Rear Seat - Grime - Small / (R) Rear Trim - Grime - Medium / Trunk Room - Worn, Scratch, Cut, Crack - Small / (L) Front Trim - Grime - Medium / (L) Front Floor Mat - Cut, Crack - Medium / Ceiling - Grime - Large / Knobs - Worn, Peel, Crack - Medium / Dashboard - Worn, Scratch, Cut, Crack - Small / Overall Interior - Smell - Yes</p>	<p>Remarks (L) Rear Fender, Molding - Scratch - Medium / (L) Rear Door, Molding - Scratch - Medium / (L) Front Door, Molding - Scratch - Large / (L) Front Fender, Molding - Scratch - Small / (L) Mirror - Scratch - Minimal / Bonnet, Headlight - Scratch - Medium / Front Bumper, Grille, Lamps - Scratch - Large / (R) Front Fender, Molding - Scratch - Medium / (R) Front Door, Molding - Scratch - Large / (R) Mirror - Scratch - Small / (R) Rear Door, Molding - Scratch & Dent - Medium / (R) Rear Fender, Molding - Scratch - Large / Trunk Hood, Rear Gate - Scratch - Medium / Rear Bumper, Lamps, Panels - Scratch - Large / Roof - Scratch - Small</p>
