## General Information

<b>Make</b>	Toyota	<b>Model</b>	Vios
<b>YOM</b>	2025	<b>Odo Meter Reading</b>	17,976
<b>Registration No.</b>	NHU3854	<b>Chassis No.</b>	PA1B18F3XR4268540
<b>CC</b>	1.3	<b>Transmission</b>	CVT
<b>Fuel Type</b>	Gas	<b>Type of Body</b>	Sedan
<b>Colour</b>	Silver

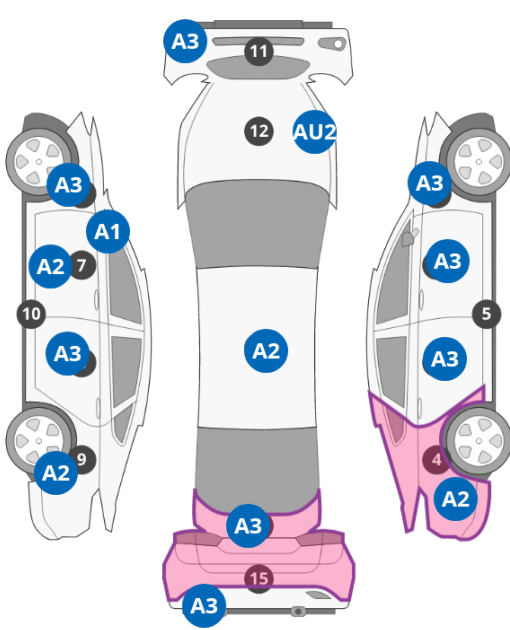
<p><b>A</b> : Scratch <b>AU</b> : Scratch &amp; Dent <b>B</b> : Modified <b>C</b> : Corrosion <b>G</b> : Stone chip <b>P</b> : Faded <b>S</b> : Rust <b>SC</b> : Rust &amp; Corrosion <b>U</b> : Dent <b>X</b> : Defective <b>Y</b> : Crack, Gap</p>
<b>Remarks</b> (R) Front Seat - Grime - Small / (R) Front Trim - Grime - Medium / Rear Seat - Grime - Medium / (R) Rear Trim - Grime - Small / Trunk Room - Worn, Scratch, Cut, Crack - Small / (L) Front Trim - Grime - Medium / (L) Front Floor Mat - Grime - Large / (L) Front Seat - Grime - Minimal / Steering Wheel - Worn, Peel, Crack - Small / Ceiling - Grime - Small / Console, Switchs, Vents - Worn, Scratch, Cut, Crack - Small	<b>Remarks</b> Trunk Hood, Rear Gate - Repair Traces - Yes / (R) Rear Fender - Repair Traces - Yes / (R) Rear Fender, Molding - Repair mark - Yes / Trunk Hood, Rear Gate - Repair mark - Yes / (L) Mirror - Scratch - Minimal / Bonnet, Headlight - Scratch & Dent - Small / Front Bumper, Grille, Lamps - Scratch - Medium / (L) Front Fender, Molding - Scratch - Medium / (L) Front Door, Molding - Scratch - Small / (L) Rear Door, Molding - Scratch - Medium / (L) Rear Fender, Molding - Scratch - Small / Trunk Hood, Rear Gate - Scratch - Medium / Rear Bumper, Lamps, Panels - Scratch - Medium / (R) Rear Fender, Molding - Scratch - Small / (R) Rear Door, Molding - Scratch - Medium / (R) Front Door, Molding - Scratch - Medium / (R) Front Fender, Molding - Scratch - Medium / Roof - Scratch - Small
