General Information

Make	Toyota	Model	Wigo
YOM	2023	Odo Meter Reading	37,280
Registration No.	DBG5629	Chassis No.	MHKA4DF5FNJ077143
CC	1.0	Transmission	A/T
Fuel Type	Gas	Type of Body	Hatchback
Colour	Yellow

Body / Panel Condition

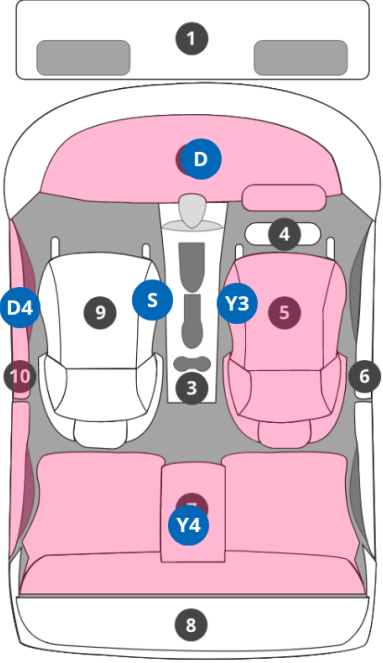
Interior Evaluation : C	Exterior Evaluation : E

<p>a : Cut, Fray d : Loose, Deformed k : Animal Hair s : Smell t : Cigarette Burns x : Defective y : Stain</p>

<p>A : Scratch AU : Scratch & Dent B : Modified C : Corrosion G : Stone chip P : Faded S : Rust SC : Rust & Corrosion U : Dent X : Defective Y : Crack, Gap</p>
<p>Remarks Rear Seat - Grime - Large / (R) Front Seat - Grime - Medium / (L) Front Trim - Worked - Large / Overall Interior - Smell - Yes / Dashboard - Traces of Adhesive Tape - Yes</p>	<p>Remarks Bonnet - Repair Traces - Yes / Front Bumper, Grille, Lamps - Crack, Gap - Large / (R) Front Fender, Molding - Scratch & Dent - Large / (R) Front Door, Molding - Scratch - Large / (R) Rear Door, Molding - Scratch - Large / (R) Rear Fender, Molding - Scratch - Medium / Rear Bumper, Lamps, Panels - Crack, Gap - Large / (L) Rear Door, Molding - Dent - Small / (L) Front Door, Molding - Scratch - Small / (L) Front Fender, Molding - Crack, Gap - Large</p>
