## General Information

| Make | Mitsubishi | Model | Strada |
| Registration No. | NBY5916 | Chassis No. | MMBJJKL10HH030476 |

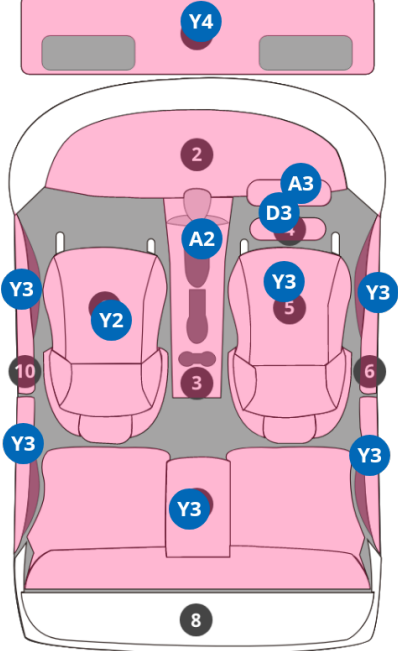
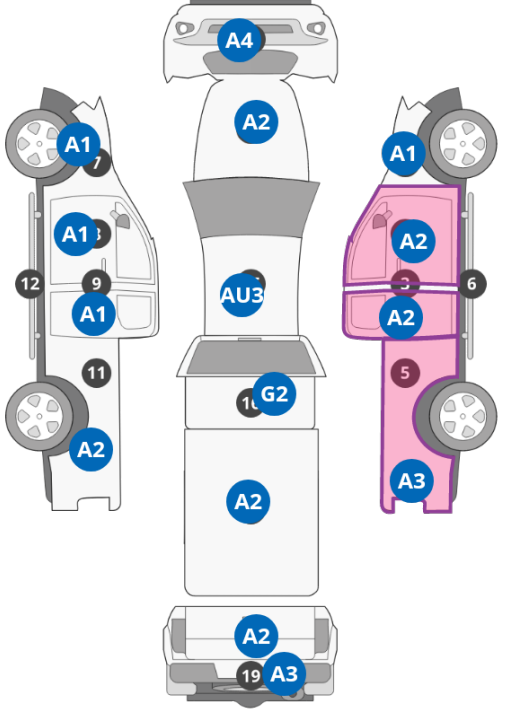
| Interior Evaluation : <b>E</b> | Exterior Evaluation : <b>E</b> |
|---|---|
| <b>Remarks</b><br>(R) Front Seat - Grime - Medium / (R) Front Trim - Grime - Medium / Rear Seat - Grime - Medium / (R) Rear Trim - Grime - Medium / (L) Rear Trim - Grime - Medium / (L) Front Trim - Grime - Medium / (L) Front Seat - Grime - Small / (L) Front Floor Mat - Crinkle - Medium / Steering Wheel - Worn, Peel, Crack - Medium / Ceiling - Grime - Large / Knobs - Worn, Peel, Crack - Small | <b>Remarks</b><br>(R) Front Door - Repair Traces - Yes / (R) Front Fender - Repair Traces - Yes / Bonnet - Repair Traces - Yes / (L) Front Fender - Repair Traces - Yes / (L) Front Door - Repair Traces - Yes / (L) Center Panel - Repair Traces - Yes / (L) Rear Door - Repair Traces - Yes / (L) Rear Corner Panel - Repair Traces - Yes / (R) Rear Door - Repair Traces - Yes / (R) Center Panel - Repair Traces - Yes / Roof - Repair Traces - Yes / (R) Front Door, Molding - Repair mark - Yes / (R) Rear Door, Molding - Repair mark - Yes / (R) Side Gate - Scratch - Medium / (R) Front Door, Molding - Scratch - Small / (R) Side Gate - Repair mark - Yes / (R) Rear Door, Molding - Scratch - Small / Bonnet, Headlight - Scratch - Small / (L) Front Door, Molding - Scratch - Minimal / (L) Front Fender, Molding - Scratch - Minimal / (L) Rear Door, Molding - Scratch - Minimal / (L) Side Gate - Scratch - Small / Rear Gate - Scratch - Small / Rear Bumper, Lamps, Panels - Scratch - Medium / Roof - Scratch & Dent - Medium / Rear Windshield - Scratch, Stone chip - Small / Cargo Bed Floor - Scratch - Small / (R) Front Fender, Molding - Scratch - Minimal / Front Bumper, Grille, Lamps - Scratch - Large |
