## General Information

<b>Make</b>	Toyota	<b>Model</b>	Vios
<b>YOM</b>	2024	<b>Odo Meter Reading</b>	40,316
<b>Registration No.</b>	DBO1837	<b>Chassis No.</b>	PA1B18F30P4237469
<b>CC</b>	1.3	<b>Transmission</b>	CVT
<b>Fuel Type</b>	Gas	<b>Type of Body</b>	Sedan
<b>Colour</b>	Red Mica Metallic

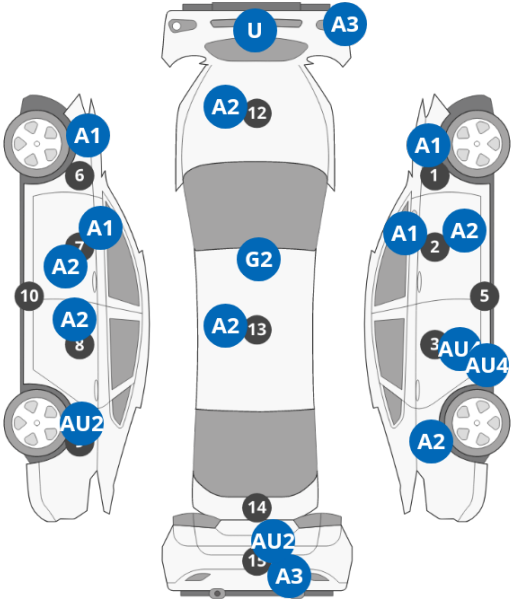
<p><b>A</b> : Scratch <b>AU</b> : Scratch &amp; Dent <b>B</b> : Modified <b>C</b> : Corrosion <b>G</b> : Stone chip <b>P</b> : Faded <b>S</b> : Rust <b>SC</b> : Rust &amp; Corrosion <b>U</b> : Dent <b>X</b> : Defective <b>Y</b> : Crack, Gap</p>
<p><b>Remarks</b> Overall Interior - Smell - Yes / Mat Other - Worked - Small / (L) Front Trim - Grime - Small / (R) Front Seat - Grime - Medium / (L) Front Seat - Grime - Medium / Ceiling - Grime - Medium / Rear Seat - Grime - Medium / (R) Rear Trim - Cut, Crack - Minimal / (R) Front Trim - Grime - Medium</p>	<p><b>Remarks</b> Front Windshield - Scratch, Stone chip - Small / Member (Bolted) - Dent - Yes / (R) Rear Door, Molding - Scratch &amp; Dent - Large / (R) Step, In-panel, Side Spoiler - Scratch &amp; Dent - Large / (R) Mirror - Scratch - Minimal / (R) Front Fender, Molding - Scratch - Minimal / (R) Front Door, Molding - Scratch - Small / (R) Rear Fender, Molding - Scratch - Small / Rear Bumper, Lamps, Panels - Scratch - Medium / Trunk Hood, Rear Gate - Scratch &amp; Dent - Small / (L) Rear Fender, Molding - Scratch &amp; Dent - Small / (L) Rear Door, Molding - Scratch - Small / (L) Front Door, Molding - Scratch - Small / (L) Mirror - Scratch - Minimal / (L) Front Fender, Molding - Scratch - Minimal / Front Bumper, Grille, Lamps - Scratch - Medium / Bonnet, Headlight - Scratch - Small / Roof - Scratch - Small</p>
