## General Information

Date & Time: 05, Jan, 2026 17:19

<b>Make</b>	Toyota	<b>Model</b>	Vios
<b>YOM</b>	2024	<b>Odo Meter Reading</b>	14,272
<b>Registration No.</b>	NKC4317	<b>Chassis No.</b>	PA1B18F30R4250693
<b>CC</b>	1.3	<b>Transmission</b>	CVT
<b>Fuel Type</b>	Gas	<b>Type of Body</b>	Sedan
<b>Colour</b>	Silver

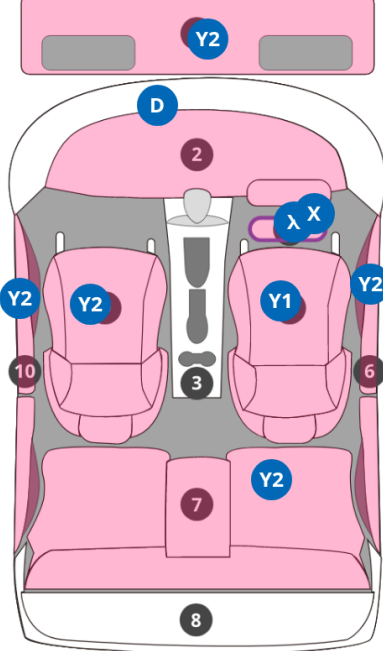
<p><b>a</b> : Cut, Fray <b>d</b> : Loose, Deformed <b>k</b> : Animal Hair <b>s</b> : Smell <b>t</b> : Cigarette Burns <b>x</b> : Defective <b>y</b> : Stain</p>

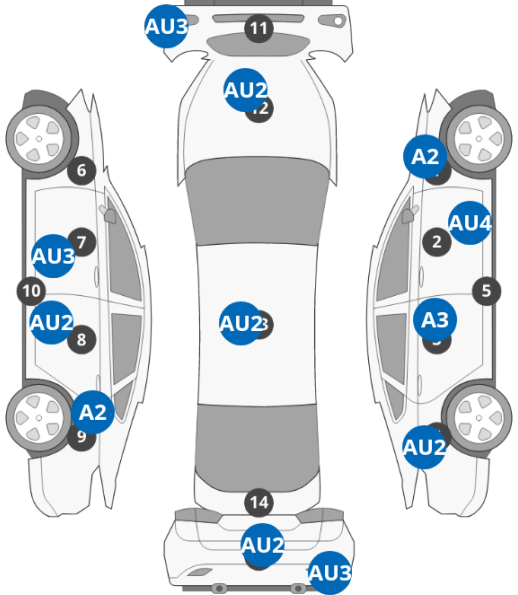
<p><b>A</b> : Scratch <b>AU</b> : Scratch &amp; Dent <b>B</b> : Modified <b>C</b> : Corrosion <b>G</b> : Stone chip <b>P</b> : Faded <b>S</b> : Rust <b>SC</b> : Rust &amp; Corrosion <b>U</b> : Dent <b>X</b> : Defective <b>Y</b> : Crack, Gap</p>
<p><b>Remarks</b> (R) Front Floor Mat - Missing - Yes / (L) Front Floor Mat - Missing - Yes / (L) Front Seat - Grime - Small / (R) Front Seat - Grime - Minimal / (R) Front Trim - Grime - Small / (L) Front Trim - Grime - Small / Rear Seat - Grime - Small / Dashboard - Traces of Adhesive Tape - Yes / Ceiling - Grime - Small</p>	<p><b>Remarks</b> Roof - Scratch &amp; Dent - Small / (L) Front Door, Molding - Scratch &amp; Dent - Medium / (L) Rear Door, Molding - Scratch &amp; Dent - Small / (L) Rear Fender, Molding - Scratch - Small / Rear Bumper, Lamps, Panels - Scratch &amp; Dent - Medium / Trunk Hood, Rear Gate - Scratch &amp; Dent - Small / (R) Rear Fender, Molding - Scratch &amp; Dent - Small / (R) Rear Door, Molding - Scratch - Medium / (R) Front Door, Molding - Scratch &amp; Dent - Large / (R) Front Fender, Molding - Scratch - Small / Bonnet, Headlight - Scratch &amp; Dent - Small / Front Bumper, Grille, Lamps - Scratch &amp; Dent - Medium</p>
