## General Information

<b>Make</b>	Toyota	<b>Model</b>	Vios
<b>YOM</b>	2025	<b>Odo Meter Reading</b>	17,815
<b>Registration No.</b>	NKI7552	<b>Chassis No.</b>	PA1B18F3XR4264715
<b>CC</b>	1.3	<b>Transmission</b>	CVT
<b>Fuel Type</b>	Gas	<b>Type of Body</b>	Sedan
<b>Colour</b>	Blue

## Body / Panel Condition

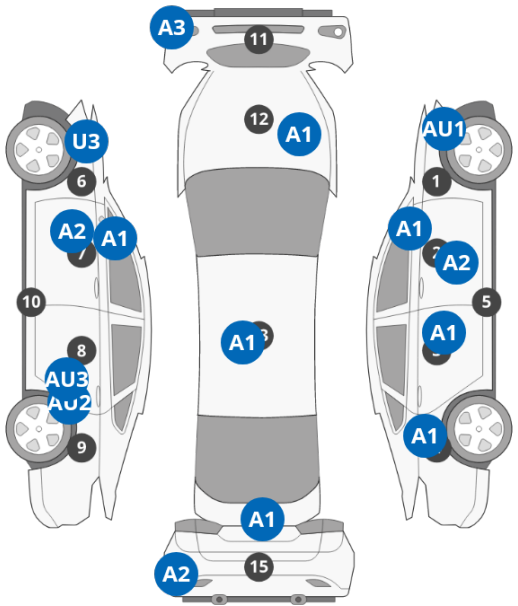
<p><b>A</b> : Scratch <b>AU</b> : Scratch &amp; Dent <b>B</b> : Modified <b>C</b> : Corrosion <b>G</b> : Stone chip <b>P</b> : Faded <b>S</b> : Rust <b>SC</b> : Rust &amp; Corrosion <b>U</b> : Dent <b>X</b> : Defective <b>Y</b> : Crack, Gap</p>
<p><b>Remarks</b> (L) Front Seat - Worn - Yes / (R) Front Seat - Grime - Small / (L) Front Floor Mat - Worked - Large / (L) Front Trim - Grime - Small / (R) Front Trim - Grime - Minimal / Ceiling - Grime - Small / Rear Seat - Grime - Small</p>	<p><b>Remarks</b> (R) Front Fender, Molding - Scratch &amp; Dent - Minimal / (R) Mirror - Scratch - Minimal / (R) Front Door, Molding - Scratch - Small / (R) Rear Door, Molding - Scratch - Minimal / (R) Rear Fender, Molding - Scratch - Minimal / Trunk Hood, Rear Gate - Scratch - Minimal / Rear Bumper, Lamps, Panels - Scratch - Small / (L) Rear Fender, Molding - Scratch &amp; Dent - Small / (L) Rear Door, Molding - Scratch &amp; Dent - Medium / (L) Front Door, Molding - Scratch - Small / (L) Front Fender, Molding - Dent - Medium / (L) Mirror - Scratch - Minimal / Front Bumper, Grille, Lamps - Scratch - Medium / Bonnet, Headlight - Scratch - Minimal / Roof - Scratch - Minimal</p>
