General Information

Make	Toyota	Model	Hiace
YOM	2022	Odo Meter Reading	284,693
Registration No.	EAF2568 - NON - MOVING	Chassis No.	JTFNAFAP0N8024381
CC	2.8	Transmission	M/T
Fuel Type	Diesel	Type of Body	Van
Colour	Silver

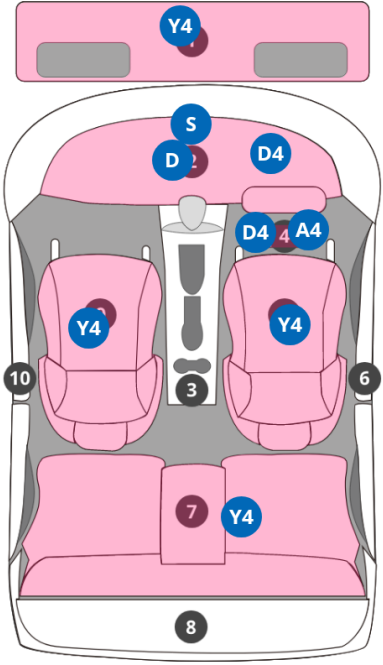
Interior Evaluation : E	Exterior Evaluation : E

<p>a : Cut, Fray d : Loose, Deformed k : Animal Hair s : Smell t : Cigarette Burns x : Defective y : Stain</p>

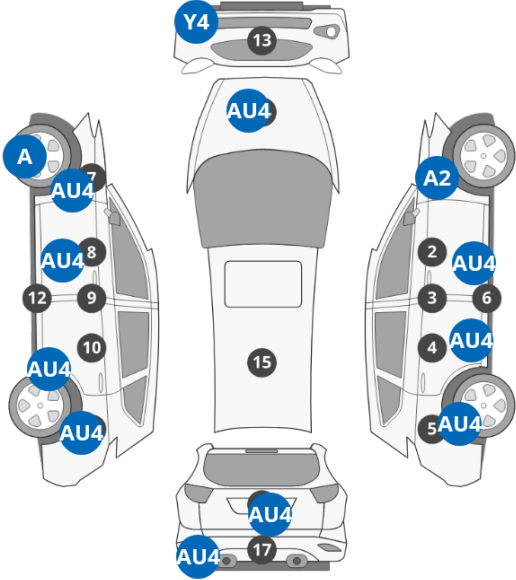
<p>A : Scratch AU : Scratch & Dent B : Modified C : Corrosion G : Stone chip P : Faded S : Rust SC : Rust & Corrosion U : Dent X : Defective Y : Crack, Gap</p>
<p>Remarks Overall Interior - Smell - Yes / Overall Interior - Worn as per age - Yes / Rear Seat - Grime - Large / Ceiling - Grime - Large / (R) Front Seat - Grime - Large / (L) Front Seat - Grime - Large / Dashboard - Loose, Deformed - Large / Dashboard - Traces of Adhesive Tape - Yes / (L) Front Floor Mat - Worked - Large / Carpet - Worn, Scratch, Cut, Crack - Large</p>	<p>Remarks (R) Step - Repair Traces - Yes / Bonnet - Repair Traces - Yes / (L) Front Fender - Repair Traces - Yes / (L) Front Door - Repair Traces - Yes / (L) Step - Repair Traces - Yes / (L) Rear Fender - Repair Traces - Yes / Trunk Hood, Rear Gate - Repair Traces - Yes / Front Bumper, Grille, Lamps - Crack, Gap - Large / (L) Front Fender, Molding - Scratch & Dent - Large / (L) Front Door, Molding - Scratch & Dent - Large / (L) Rear Door, Molding - Scratch & Dent - Large / (L) Front Tyre - Crack, Cut - Yes / (L) Rear Fender, Molding - Scratch & Dent - Large / Rear Bumper, Lamps, Panels - Scratch & Dent - Large / Trunk Hood, Rear Gate - Scratch & Dent - Large / (R) Rear Fender, Molding - Scratch & Dent - Large / (R) Rear Door, Molding - Scratch & Dent - Large / (R) Front Door, Molding - Scratch & Dent - Large / (R) Front Fender, Molding - Scratch - Small / Bonnet, Headlight - Scratch & Dent - Large</p>
