General Information

Date & Time: 06, Jan, 2026 13:29

Make	Toyota	Model	Avanza
YOM	2025	Odo Meter Reading	34,681
Registration No.	NJF1086	Chassis No.	MHFAA1BY4R0033420
CC	1.3	Transmission	CVT
Fuel Type	Gas	Type of Body	MPV
Colour	Black

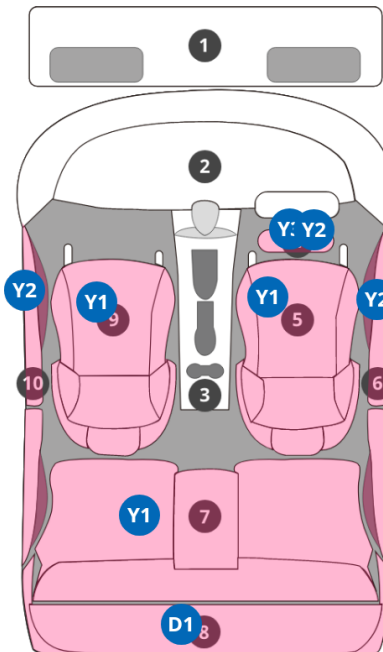
Interior Evaluation : B	Exterior Evaluation : D

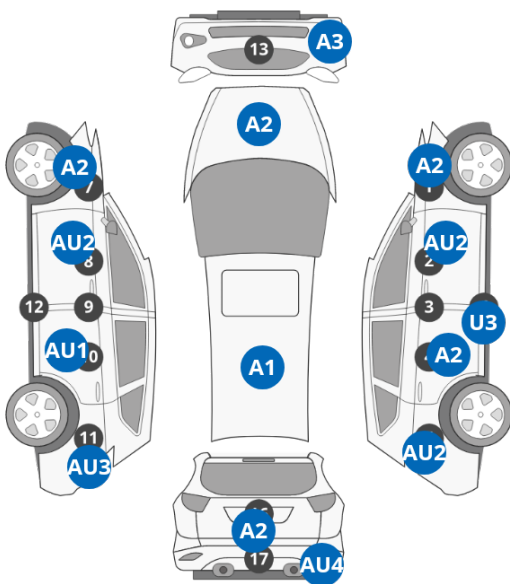
<p>A : Scratch AU : Scratch & Dent B : Modified C : Corrosion G : Stone chip P : Faded S : Rust SC : Rust & Corrosion U : Dent X : Defective Y : Crack, Gap</p>
Remarks (L) Front Floor Mat - Grime - Medium / (R) Front Floor Mat - Grime - Small / (L) Front Trim - Grime - Small / (R) Front Seat - Grime - Minimal / Rear Seat - Grime - Minimal / Trunk Room - Worked - Minimal	Remarks (L) Step - Repair Traces - Yes / Roof - Repair Traces - Yes / Rear Bumper, Lamps, Panels - Scratch & Dent - Large / (L) Rear Fender, Molding - Scratch & Dent - Medium / (L) Front Door, Molding - Scratch & Dent - Small / (L) Front Fender, Molding - Scratch - Small / Bonnet, Headlight - Scratch - Small / (R) Front Door, Molding - Scratch & Dent - Small / (R) Rear Door, Molding - Scratch - Small / (R) Rear Fender, Molding - Scratch & Dent - Small / Trunk Hood, Rear Gate - Scratch - Small / Roof - Scratch - Minimal / (L) Rear Door, Molding - Scratch & Dent - Minimal / Front Bumper, Grille, Lamps - Scratch - Medium / (R) Front Fender, Molding - Scratch - Small / (R) Step, In-panel, Side Spoiler - Dent - Medium
