General Information

Make	Toyota	Model	Avanza
YOM	2025	Odo Meter Reading	3,228
Registration No.	CCG7299	Chassis No.	MHFAA1BY5S0038583
CC	1.3	Transmission	CVT
Fuel Type	Gas	Type of Body	Wagon
Colour	Red

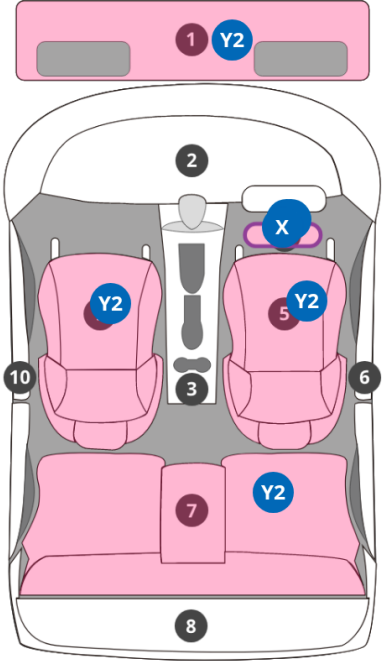
Interior Evaluation : B	Exterior Evaluation : E

<p>a : Cut, Fray d : Loose, Deformed k : Animal Hair s : Smell t : Cigarette Burns x : Defective y : Stain</p>

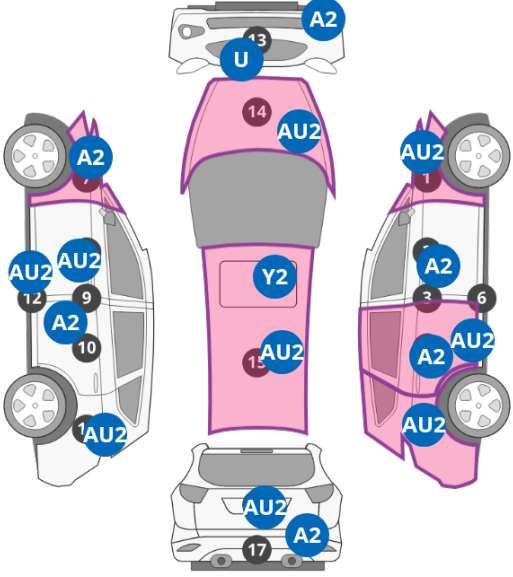
<p>A : Scratch AU : Scratch & Dent B : Modified C : Corrosion G : Stone chip P : Faded S : Rust SC : Rust & Corrosion U : Dent X : Defective Y : Crack, Gap</p>
Remarks Mat Other - Missing - Yes / (L) Front Floor Mat - Missing - Yes / (R) Front Floor Mat - Missing - Yes / (L) Front Seat - Grime - Small / (R) Front Seat - Grime - Small / Rear Seat - Grime - Small / Ceiling - Grime - Small	Remarks (R) Front Fender - Repair Traces - Yes / Bonnet - Repair Traces - Yes / (L) Front Fender - Repair Traces - Yes / Trunk Hood, Rear Gate - Repair Traces - Yes / (R) Rear Fender - Repair Traces - Yes / (R) Rear Fender - Replaced - Yes / Roof - Repair Traces - Yes / Roof - Repair mark - Yes / (L) Front Fender, Molding - Repair mark - Yes / Bonnet, Headlight - Repair mark - Yes / (R) Front Fender, Molding - Repair mark - Yes / (R) Rear Door, Molding - Repair mark - Yes / Trunk Hood, Rear Gate - Scratch & Dent - Small / Rear Bumper, Lamps, Panels - Scratch - Small / (R) Rear Fender, Molding - Scratch & Dent - Small / (R) Rear Door, Molding - Scratch - Small / (R) Step, In-panel, Side Spoiler - Scratch & Dent - Small / (R) Front Door, Molding - Scratch - Small / (R) Front Fender, Molding - Scratch & Dent - Small / Front Windshield - Damaged - Small / Bonnet, Headlight - Scratch & Dent - Small / Roof - Scratch & Dent - Small / Member (Bolted) - Dent - Yes / Front Bumper, Grille, Lamps - Scratch - Small / (L) Front Fender, Molding - Scratch - Small / (L) Front Door, Molding - Scratch & Dent - Small / (L) Step, In-panel, Side Spoiler - Scratch & Dent - Small / (L) Rear Door, Molding - Scratch - Small / (L) Rear Fender, Molding - Scratch & Dent - Small
