## General Information

<b>Make</b>	Toyota	<b>Model</b>	Vios
<b>YOM</b>	2025	<b>Odo Meter Reading</b>	12,596
<b>Registration No.</b>	NEY6552	<b>Chassis No.</b>	PA1B18F34R4263432
<b>CC</b>	1.3	<b>Transmission</b>	CVT
<b>Fuel Type</b>	Gas	<b>Type of Body</b>	Sedan
<b>Colour</b>	Red

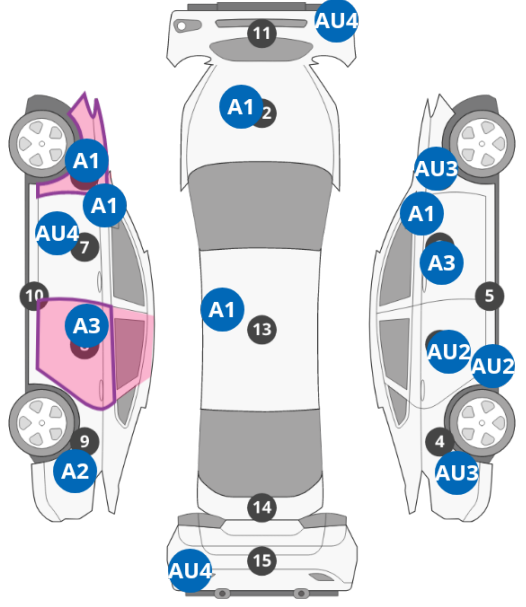
<p><b>A</b> : Scratch <b>AU</b> : Scratch &amp; Dent <b>B</b> : Modified <b>C</b> : Corrosion <b>G</b> : Stone chip <b>P</b> : Faded <b>S</b> : Rust <b>SC</b> : Rust &amp; Corrosion <b>U</b> : Dent <b>X</b> : Defective <b>Y</b> : Crack, Gap</p>
<b>Remarks</b> (L) Front Floor Mat - Missing - Yes / (R) Front Floor Mat - Worked - Small	<b>Remarks</b> (L) Front Fender - Repair Traces - Yes / (R) Front Fender, Molding - Scratch & Dent - Medium / (R) Mirror - Scratch - Minimal / (R) Front Door, Molding - Scratch - Medium / (R) Rear Door, Molding - Scratch & Dent - Small / (R) Rear Fender, Molding - Scratch & Dent - Medium / Rear Bumper, Lamps, Panels - Scratch & Dent - Large / (L) Rear Fender, Molding - Scratch - Small / (L) Rear Door, Molding - Repair mark - Yes / (L) Rear Door, Molding - Scratch - Medium / (L) Front Door, Molding - Scratch & Dent - Large / (L) Mirror - Scratch - Minimal / Bonnet, Headlight - Scratch - Minimal / Front Bumper, Grille, Lamps - Scratch & Dent - Large / (L) Front Fender, Molding - Repair mark - Difference in Color / Roof - Scratch - Minimal / (R) Step, In-panel, Side Spoiler - Scratch & Dent - Small / (L) Front Fender, Molding - Scratch - Minimal

<b>Inspector Notes</b>
With Lto plate, with spare tire, with jack and tools, 1key, no warranty booklet, cracked and scratches on taillight and headlight
