General Information

| Make | Toyota | Model | Vios |
| Registration No. | CBI1516 | Chassis No. | PA1B18F38P4208690 |

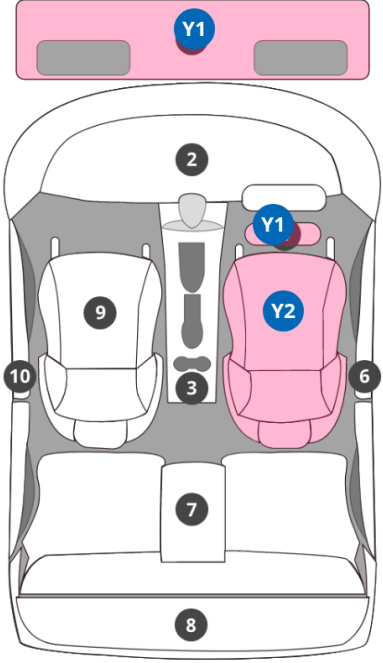
| Interior Evaluation : A | Exterior Evaluation : C |
| <p>Remarks (R) Front Seat - Grime - Small / Ceiling - Grime - Minimal / (L) Front Floor Mat - Grime - Minimal</p> | <p>Remarks (R) Front Fender - Repair Traces - Yes / (L) Front Fender - Repair Traces - Yes / (L) Rear Fender - Repair Traces - Yes / (R) Front Fender, Molding - Repair mark - Yes / (R) Front Fender, Molding - Scratch - Minimal / (R) Mirror - Scratch - Small / (R) Front Door, Molding - Scratch - Small / (R) Rear Door, Molding - Scratch - Minimal / (R) Rear Fender, Molding - Scratch - Minimal / Trunk Hood, Rear Gate - Scratch - Minimal / Rear Bumper, Lamps, Panels - Scratch & Dent - Small / (L) Rear Fender, Molding - Repair mark - Yes / (L) Rear Fender, Molding - Scratch - Small / (L) Rear Door, Molding - Repair mark - Yes / (L) Rear Door, Molding - Scratch - Small / (L) Front Door, Molding - Scratch - Minimal / (L) Mirror - Scratch - Minimal / Front Bumper, Grille, Lamps - Crack, Gap - Small / Bonnet, Headlight - Scratch - Minimal</p> |

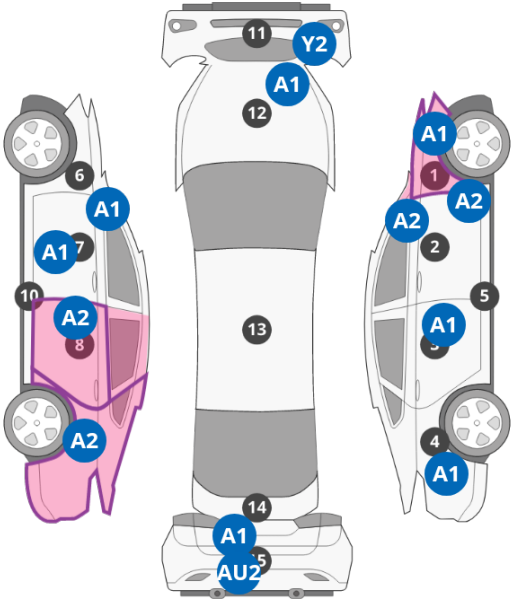
| <p>No Lto plate, with warranty booklet, with jack, no spare tire and tools, 2keys, scratches on headlights and taillight</p> |
