## General Information

Date & Time: 06, Jan, 2026 12:34

<b>Make</b>	Suzuki	<b>Model</b>	Dzire
<b>YOM</b>	2024	<b>Odo Meter Reading</b>	13,921
<b>Registration No.</b>	GBC6920	<b>Chassis No.</b>	MBHZF63S3RG474240
<b>CC</b>	1.2	<b>Transmission</b>	A/T
<b>Fuel Type</b>	Gas	<b>Type of Body</b>	Sedan
<b>Colour</b>	Blue

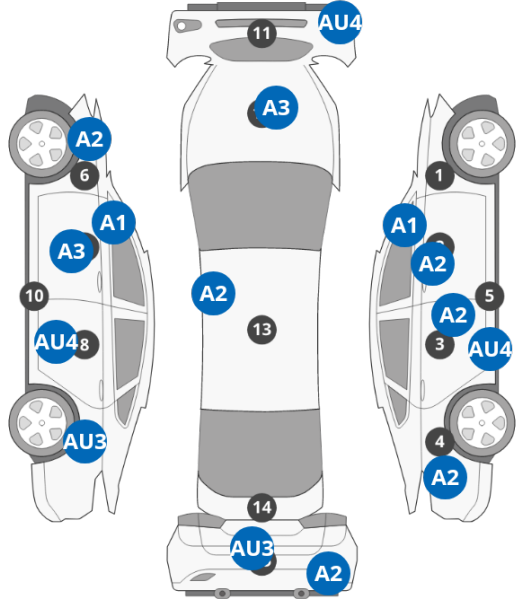
<p><b>A</b> : Scratch <b>AU</b> : Scratch &amp; Dent <b>B</b> : Modified <b>C</b> : Corrosion <b>G</b> : Stone chip <b>P</b> : Faded <b>S</b> : Rust <b>SC</b> : Rust &amp; Corrosion <b>U</b> : Dent <b>X</b> : Defective <b>Y</b> : Crack, Gap</p>
<p><b>Remarks</b> Ceiling - Grime - Minimal / (R) Front Floor Mat - Grime - Small / (R) Front Trim - Grime - Small / (L) Front Trim - Grime - Small / (L) Front Floor Mat - Worked - Small</p>	<p><b>Remarks</b> Bonnet, Headlight - Scratch - Medium / Front Bumper, Grille, Lamps - Scratch &amp; Dent - Large / (L) Front Fender, Molding - Scratch - Small / (L) Front Door, Molding - Scratch - Medium / (L) Mirror - Scratch - Minimal / (L) Rear Door, Molding - Scratch &amp; Dent - Large / (L) Rear Fender, Molding - Scratch &amp; Dent - Medium / Trunk Hood, Rear Gate - Scratch &amp; Dent - Medium / Rear Bumper, Lamps, Panels - Scratch - Small / (R) Rear Fender, Molding - Scratch - Small / (R) Rear Door, Molding - Scratch - Small / (R) Step, In-panel, Side Spoiler - Scratch &amp; Dent - Large / (R) Mirror - Scratch - Minimal / (R) Front Door, Molding - Scratch - Small / Roof - Scratch - Small</p>
