General Information

Make	Toyota	Model	Vios
YOM	2025	Odo Meter Reading	1,234
Registration No.	GBF1986	Chassis No.	PA1B18F37R42621162
CC	1.3	Transmission	CVT
Fuel Type	Gas	Type of Body	Sedan
Colour	Black

Body / Panel Condition

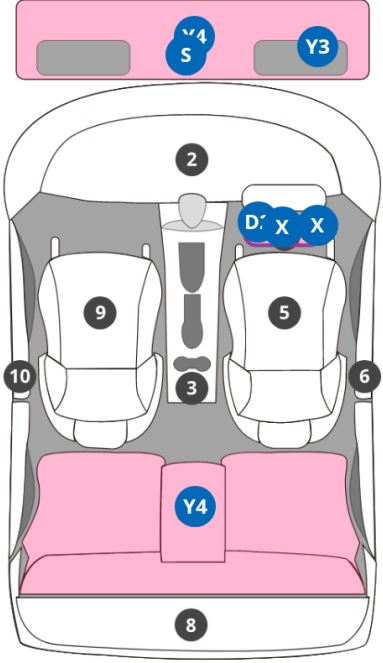
Interior Evaluation : C	Exterior Evaluation : C

<p>a : Cut, Fray d : Loose, Deformed k : Animal Hair s : Smell t : Cigarette Burns x : Defective y : Stain</p>

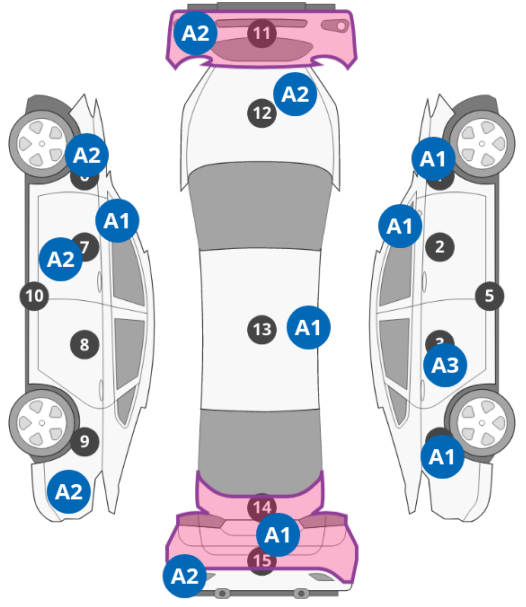
<p>A : Scratch AU : Scratch & Dent B : Modified C : Corrosion G : Stone chip P : Faded S : Rust SC : Rust & Corrosion U : Dent X : Defective Y : Crack, Gap</p>
Remarks Ceiling - Grime - Large / Overall Interior - Smell - Yes / Sunvisor, Sunglass Holder - Grime - Medium / (L) Front Floor Mat - Worked - Small / (R) Front Floor Mat - Missing - Yes / Mat Other - Missing - Yes / Rear Seat - Grime - Large	Remarks Trunk Hood, Rear Gate - Repair Traces - Yes / Rear End Panel - Repair Traces - Yes / Bonnet, Headlight - Scratch - Small / (R) Front Fender, Molding - Scratch - Minimal / (R) Mirror - Scratch - Minimal / (R) Rear Door, Molding - Scratch - Medium / (R) Rear Fender, Molding - Scratch - Minimal / Rear Bumper, Lamps, Panels - Scratch - Small / (L) Rear Fender, Molding - Scratch - Small / Trunk Hood, Rear Gate - Scratch - Minimal / (L) Front Door, Molding - Scratch - Small / (L) Mirror - Scratch - Minimal / (L) Front Fender, Molding - Scratch - Small / Front Bumper, Grille, Lamps - Scratch - Small / Roof - Scratch - Minimal / Trunk Hood, Rear Gate - Repair mark - Yes / Front Bumper, Grille, Lamps - Repair mark - Yes
