## General Information

Date & Time: 23, Dec, 2025 15:51

<b>Make</b>	Toyota	<b>Model</b>	Vios
<b>YOM</b>	2022	<b>Odo Meter Reading</b>	53,248
<b>Registration No.</b>	CAX2043	<b>Chassis No.</b>	PA1B18F31M4167752
<b>CC</b>	1.3	<b>Transmission</b>	CVT
<b>Fuel Type</b>	Gas	<b>Type of Body</b>	Sedan
<b>Colour</b>	Red Mica Metallic

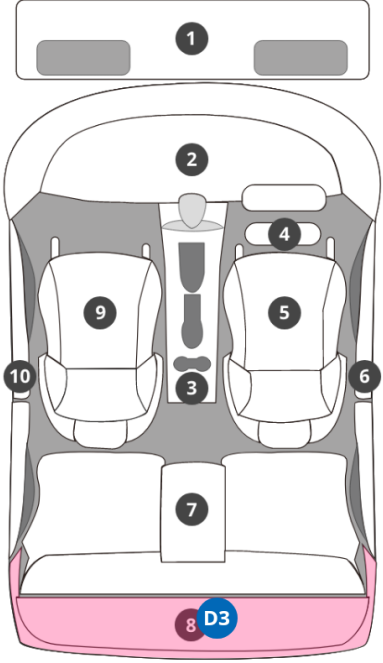
<b>Interior Evaluation :</b> <span style="float: right; color: red; font-weight: bold;">B</span>	<b>Exterior Evaluation :</b> <span style="float: right; color: red; font-weight: bold;">C</span>

<p><b>A</b> : Scratch <b>AU</b> : Scratch &amp; Dent <b>B</b> : Modified <b>C</b> : Corrosion <b>G</b> : Stone chip <b>P</b> : Faded <b>S</b> : Rust <b>SC</b> : Rust &amp; Corrosion <b>U</b> : Dent <b>X</b> : Defective <b>Y</b> : Crack, Gap</p>
<b>Remarks</b> Trunk Room - Loose, Deformed - Medium	<b>Remarks</b> (R) Front Fender, Molding - Scratch & Dent - Medium / (R) Front Door, Molding - Scratch & Dent - Large / (R) Rear Door, Molding - Scratch & Dent - Small / (R) Rear Fender, Molding - Scratch - Minimal / Rear Bumper, Lamps, Panels - Scratch & Dent - Small / Trunk Hood, Rear Gate - Scratch - Minimal / (L) Rear Fender, Molding - Scratch - Minimal / (L) Rear Door, Molding - Scratch & Dent - Minimal / (L) Front Door, Molding - Scratch - Minimal / (L) Mirror - Scratch - Minimal / (L) Front Fender, Molding - Scratch - Minimal / Front Bumper, Grille, Lamps - Scratch & Dent - Large / Bonnet, Headlight - Scratch - Minimal / Roof - Dent - Small

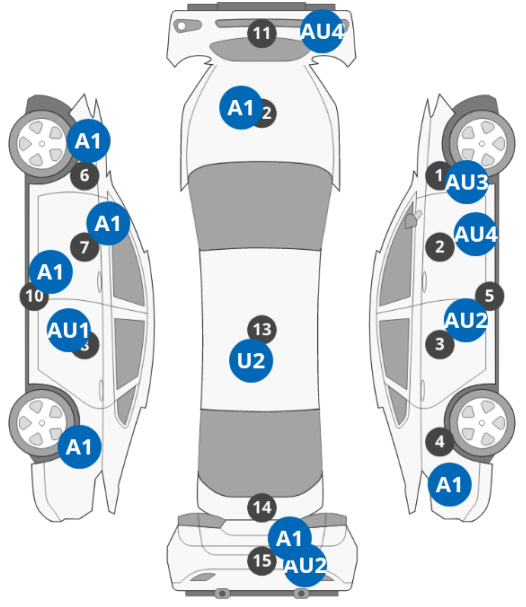
<b>Inspector Notes</b>
With Lto plate, with warranty booklet, with spare and jack, 1key, no tools, scratches on headlights and taillight, truck room issue
