## General Information

<b>Make</b>	Toyota	<b>Model</b>	Hiace
<b>YOM</b>	2021	<b>Odo Meter Reading</b>	98,792
<b>Registration No.</b>	DAT1737	<b>Chassis No.</b>	JTFJT02P1L5024201
<b>CC</b>	3.0	<b>Transmission</b>	M/T
<b>Fuel Type</b>	Diesel	<b>Type of Body</b>	Van
<b>Colour</b>	Silver

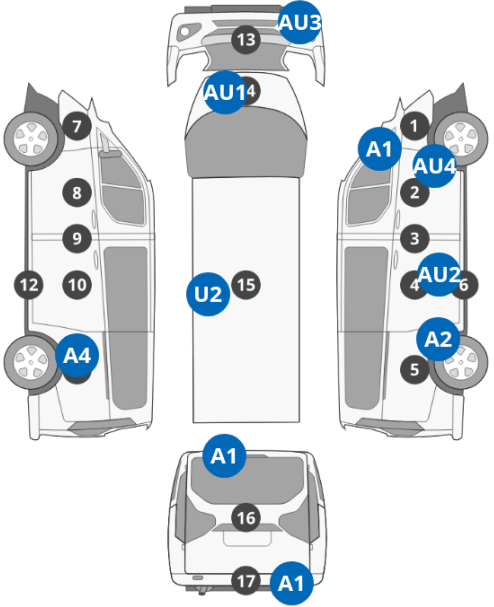
<p><b>A</b> : Scratch <b>AU</b> : Scratch &amp; Dent <b>B</b> : Modified <b>C</b> : Corrosion <b>G</b> : Stone chip <b>P</b> : Faded <b>S</b> : Rust <b>SC</b> : Rust &amp; Corrosion <b>U</b> : Dent <b>X</b> : Defective <b>Y</b> : Crack, Gap</p>
<b>Remarks</b> Ceiling - Grime - Small	<b>Remarks</b> (R) Front Door, Molding - Scratch & Dent - Large / (R) Mirror - Scratch - Minimal / (R) Rear Door, Molding - Scratch & Dent - Small / (R) Rear Fender, Molding - Scratch - Small / Trunk Hood, Rear Gate - Scratch - Minimal / (L) Rear Fender, Molding - Scratch - Large / Rear Bumper, Lamps, Panels - Scratch - Minimal / Roof - Dent - Small / Front Bumper, Grille, Lamps - Scratch & Dent - Medium / Bonnet, Headlight - Scratch & Dent - Minimal
