## General Information

<b>Make</b>	Toyota	<b>Model</b>	Vios
<b>YOM</b>	2024	<b>Odo Meter Reading</b>	44,552
<b>Registration No.</b>	NHM3541	<b>Chassis No.</b>	PA1B18F37R4239674
<b>CC</b>	1.3	<b>Transmission</b>	CVT
<b>Fuel Type</b>	Gas	<b>Type of Body</b>	Sedan
<b>Colour</b>	White

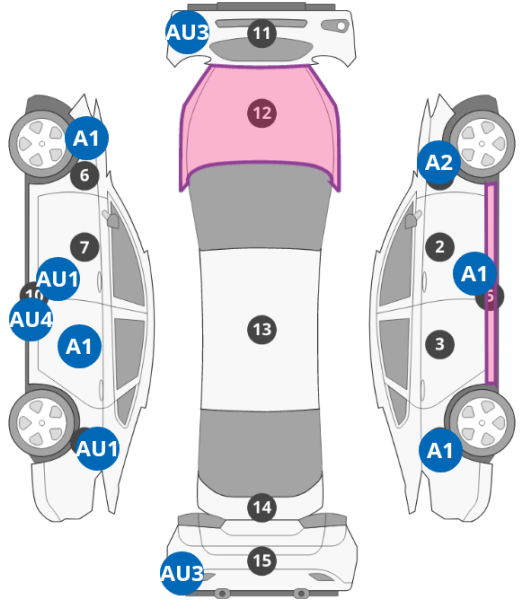
<p><b>A</b> : Scratch <b>AU</b> : Scratch &amp; Dent <b>B</b> : Modified <b>C</b> : Corrosion <b>G</b> : Stone chip <b>P</b> : Faded <b>S</b> : Rust <b>SC</b> : Rust &amp; Corrosion <b>U</b> : Dent <b>X</b> : Defective <b>Y</b> : Crack, Gap</p>
<p><b>Remarks</b> Defects not found</p>	<p><b>Remarks</b> (R) Front Fender, Molding - Scratch - Small / (R) Front Door, Molding - Scratch - Minimal / (R) Step, In-panel, Side Spoiler - Repair mark - Yes / (R) Rear Fender, Molding - Scratch - Minimal / Rear Bumper, Lamps, Panels - Scratch &amp; Dent - Medium / (L) Rear Fender, Molding - Scratch &amp; Dent - Minimal / (L) Rear Door, Molding - Scratch - Minimal / (L) Step, In-panel, Side Spoiler - Scratch &amp; Dent - Large / (L) Front Door, Molding - Scratch &amp; Dent - Minimal / (L) Front Fender, Molding - Scratch - Minimal / Bonnet, Headlight - Repair mark - Yes / Front Bumper, Grille, Lamps - Scratch &amp; Dent - Medium</p>
