## General Information

<b>Make</b>	Toyota	<b>Model</b>	Vios
<b>YOM</b>	2021	<b>Odo Meter Reading</b>	64,899
<b>Registration No.</b>	NFI1918	<b>Chassis No.</b>	PAB1B18F31M4154290
<b>CC</b>	1.3	<b>Transmission</b>	CVT
<b>Fuel Type</b>	Gas	<b>Type of Body</b>	Sedan
<b>Colour</b>	Silver

## Body / Panel Condition

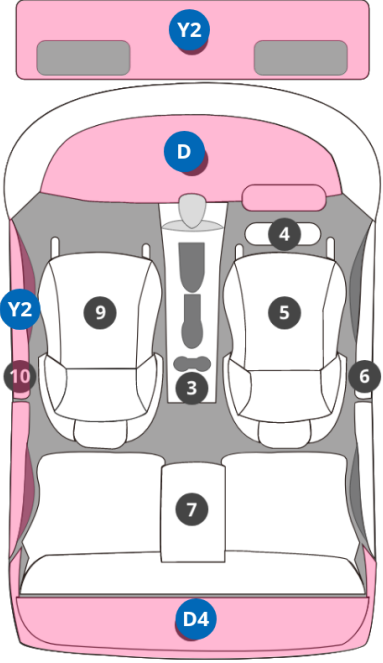
<b>Interior Evaluation :</b> <span style="float: right; color: red; font-weight: bold;">C</span>	<b>Exterior Evaluation :</b> <span style="float: right; color: red; font-weight: bold;">C</span>

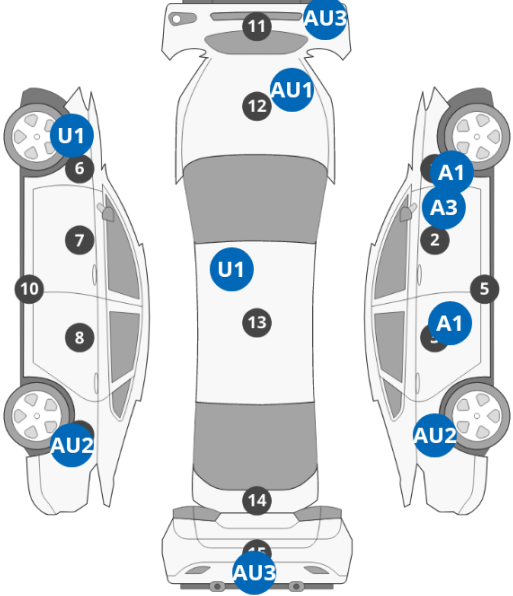
<p><b>A</b> : Scratch <b>AU</b> : Scratch &amp; Dent <b>B</b> : Modified <b>C</b> : Corrosion <b>G</b> : Stone chip <b>P</b> : Faded <b>S</b> : Rust <b>SC</b> : Rust &amp; Corrosion <b>U</b> : Dent <b>X</b> : Defective <b>Y</b> : Crack, Gap</p>
<p><b>Remarks</b> Dashboard - Traces of Adhesive Tape - Yes / Ceiling - Grime - Small / Trunk Room - Loose, Deformed - Large / (L) Front Trim - Grime - Small</p>	<p><b>Remarks</b> (R) Front Fender, Molding - Scratch - Minimal / (R) Front Door, Molding - Scratch - Medium / (R) Rear Door, Molding - Scratch - Minimal / (R) Rear Fender, Molding - Scratch &amp; Dent - Small / Rear Bumper, Lamps, Panels - Scratch &amp; Dent - Medium / (L) Rear Fender, Molding - Scratch &amp; Dent - Small / (L) Front Fender, Molding - Dent - Minimal / Roof - Dent - Minimal / Front Bumper, Grille, Lamps - Scratch &amp; Dent - Medium / Bonnet, Headlight - Scratch &amp; Dent - Minimal</p>
