## General Information

Date & Time: 10, Jan, 2026 18:54

<b>Make</b>	Toyota	<b>Model</b>	Vios
<b>YOM</b>	2022	<b>Odo Meter Reading</b>	157,336
<b>Registration No.</b>	NFG5849	<b>Chassis No.</b>	PA1B18F32M4162835
<b>CC</b>	1.3	<b>Transmission</b>	CVT
<b>Fuel Type</b>	Gas	<b>Type of Body</b>	Sedan
<b>Colour</b>	Silver

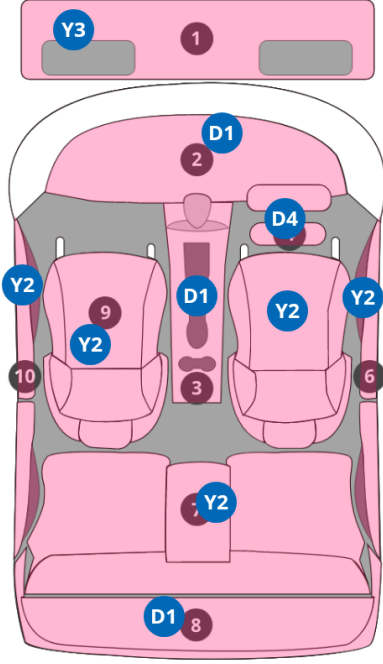
<p><b>Interior Evaluation :</b> <span style="float: right;"><b>C</b></span></p>	<p><b>Exterior Evaluation :</b> <span style="float: right;"><b>E</b></span></p>

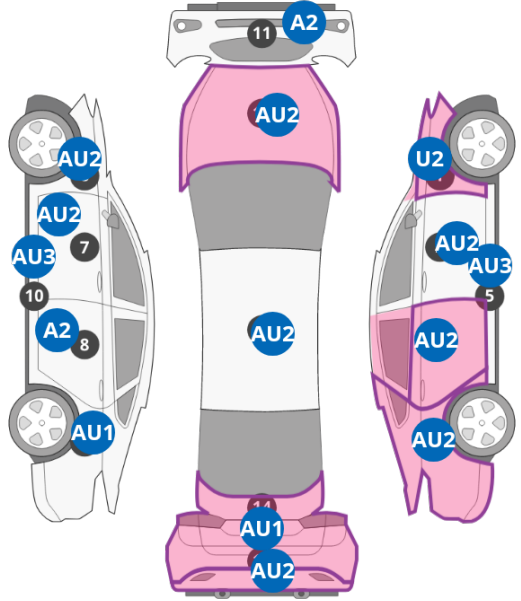
<p><b>A</b> : Scratch <b>AU</b> : Scratch &amp; Dent <b>B</b> : Modified <b>C</b> : Corrosion <b>G</b> : Stone chip <b>P</b> : Faded <b>S</b> : Rust <b>SC</b> : Rust &amp; Corrosion <b>U</b> : Dent <b>X</b> : Defective <b>Y</b> : Crack, Gap</p>
<p><b>Remarks</b> (L) Front Floor Mat - Worked - Large / (L) Front Seat - Grime - Small / (R) Front Seat - Grime - Small / Console, Switchs, Vents - Worked - Minimal / Ceiling - Grime - Medium / (L) Front Trim - Grime - Small / (R) Front Trim - Grime - Small / Rear Seat - Grime - Small / Trunk Room - Worked - Minimal / Dashboard - Worked - Minimal</p>	<p><b>Remarks</b> (R) Front Door - Repair Traces - Yes / (R) Front Fender - Repair Traces - Yes / Bonnet - Repair Traces - Yes / (L) Front Fender - Repair Traces - Yes / (L) Front Door - Repair Traces - Yes / (L) Rear Door - Repair Traces - Yes / (L) Rear Fender - Repair Traces - Yes / Trunk Hood, Rear Gate - Repair Traces - Yes / (R) Rear Fender - Repair Traces - Yes / (R) Rear Door - Repair Traces - Yes / Roof - Repair Traces - Yes / (R) Front Fender, Molding - Repair mark - Yes / (L) Front Fender, Molding - Scratch &amp; Dent - Small / Front Bumper, Grille, Lamps - Scratch - Small / Bonnet, Headlight - Repair mark - Yes / Bonnet, Headlight - Scratch &amp; Dent - Small / (R) Front Fender, Molding - Dent - Small / (R) Step, In-panel, Side Spoiler - Scratch &amp; Dent - Medium / (R) Front Door, Molding - Scratch &amp; Dent - Small / (R) Rear Door, Molding - Scratch &amp; Dent - Small / (R) Rear Door, Molding - Repair mark - Yes / (R) Rear Fender, Molding - Scratch &amp; Dent - Small / (R) Rear Fender, Molding - Repair mark - Yes / Rear Bumper, Lamps, Panels - Repair mark - Yes / Rear Bumper, Lamps, Panels - Scratch &amp; Dent - Small / Trunk Hood, Rear Gate - Scratch &amp; Dent - Minimal / Trunk Hood, Rear Gate - Repair mark - Yes / Overall Exterior - Full Re-Paint in same color - Yes / (L) Rear Fender, Molding - Scratch &amp; Dent - Minimal / (L) Rear Door, Molding - Scratch - Small / (L) Step, In-panel, Side Spoiler - Scratch &amp; Dent - Medium / (L) Front Door, Molding - Scratch &amp; Dent - Small / Roof - Scratch &amp; Dent - Small</p>
