## General Information

<b>Make</b>	Toyota	<b>Model</b>	Vios
<b>YOM</b>	2021	<b>Odo Meter Reading</b>	119,994
<b>Registration No.</b>	NEO9373	<b>Chassis No.</b>	PA1B18F36M4157511
<b>CC</b>	1.3	<b>Transmission</b>	CVT
<b>Fuel Type</b>	Gas	<b>Type of Body</b>	Sedan
<b>Colour</b>	Green

## Body / Panel Condition

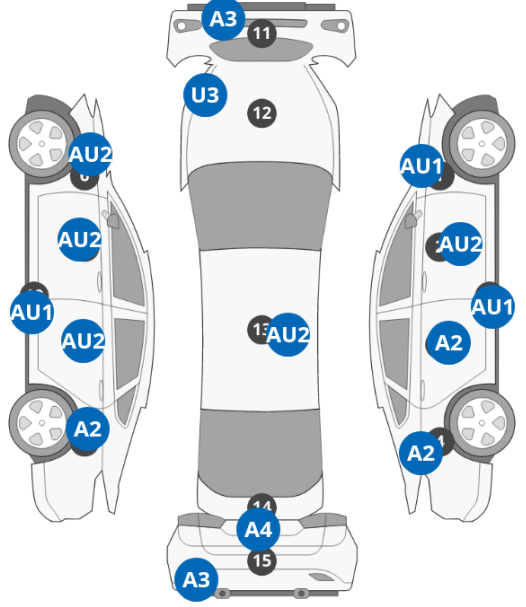
<p><b>A</b> : Scratch <b>AU</b> : Scratch &amp; Dent <b>B</b> : Modified <b>C</b> : Corrosion <b>G</b> : Stone chip <b>P</b> : Faded <b>S</b> : Rust <b>SC</b> : Rust &amp; Corrosion <b>U</b> : Dent <b>X</b> : Defective <b>Y</b> : Crack, Gap</p>
<p><b>Remarks</b> (L) Front Floor Mat - Grime - Small / (R) Front Floor Mat - Grime - Small / (L) Front Seat - Cut, Crack - Medium / Rear Seat - Cut, Crack - Small / (L) Front Trim - Grime - Small / (R) Front Seat - Cut, Crack - Medium / Trunk Room - Worn, Scratch, Cut, Crack - Small</p>	<p><b>Remarks</b> (L) Front Fender, Molding - Scratch &amp; Dent - Small / (L) Front Door, Molding - Scratch &amp; Dent - Small / (L) Rear Door, Molding - Scratch &amp; Dent - Small / (L) Rear Fender, Molding - Scratch - Small / Rear Bumper, Lamps, Panels - Scratch - Medium / Trunk Hood, Rear Gate - Scratch - Large / (R) Rear Fender, Molding - Scratch - Small / (R) Rear Door, Molding - Scratch - Small / (R) Front Door, Molding - Scratch &amp; Dent - Small / (R) Front Fender, Molding - Scratch &amp; Dent - Minimal / Bonnet, Headlight - Dent - Medium / Front Bumper, Grille, Lamps - Scratch - Medium / Roof - Scratch &amp; Dent - Small / (L) Step, In-panel, Side Spoiler - Scratch &amp; Dent - Minimal / (R) Step, In-panel, Side Spoiler - Scratch &amp; Dent - Minimal</p>
