## General Information

<b>Make</b>	Toyota	<b>Model</b>	Hilux
<b>YOM</b>	2025	<b>Odo Meter Reading</b>	24,330
<b>Registration No.</b>	BAG7907	<b>Chassis No.</b>	MR0JB8DD5R3554707
<b>CC</b>	2.4	<b>Transmission</b>	A/T
<b>Fuel Type</b>	Diesel	<b>Type of Body</b>	Pickup
<b>Colour</b>	Black

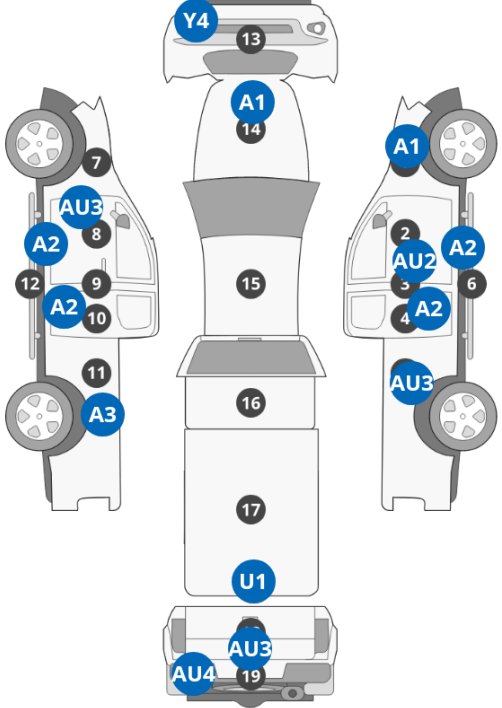
<p><b>A</b> : Scratch <b>AU</b> : Scratch &amp; Dent <b>B</b> : Modified <b>C</b> : Corrosion <b>G</b> : Stone chip <b>P</b> : Faded <b>S</b> : Rust <b>SC</b> : Rust &amp; Corrosion <b>U</b> : Dent <b>X</b> : Defective <b>Y</b> : Crack, Gap</p>
<p><b>Remarks</b> Ceiling - Grime - Minimal / (L) Front Floor Mat - Grime - Medium / (R) Front Floor Mat - Missing - Yes / (L) Rear Trim - Cut, Crack - Minimal / (R) Rear Trim - Grime - Small / (R) Front Trim - Grime - Minimal</p>	<p><b>Remarks</b> (R) Front Fender, Molding - Scratch - Minimal / (R) Front Door, Molding - Scratch &amp; Dent - Small / (R) Rear Door, Molding - Scratch - Small / (R) Step, In-panel, Side Spoiler - Scratch - Small / (R) Side Gate - Scratch &amp; Dent - Medium / Rear Gate - Scratch &amp; Dent - Medium / Rear Bumper, Lamps, Panels - Scratch &amp; Dent - Large / (L) Side Gate - Scratch - Medium / (L) Rear Door, Molding - Scratch - Small / (L) Step, In-panel, Side Spoiler - Scratch - Small / (L) Front Door, Molding - Scratch &amp; Dent - Medium / Front Bumper, Grille, Lamps - Crack, Gap - Large / Bonnet, Headlight - Scratch - Minimal / Roof - Dent - Minimal</p>
