## General Information

<b>Make</b>	Toyota	<b>Model</b>	Vios
<b>YOM</b>	2024	<b>Odo Meter Reading</b>	10,347
<b>Registration No.</b>	NKC6697	<b>Chassis No.</b>	PA1B18F37R4236488
<b>CC</b>	1.3	<b>Transmission</b>	CVT
<b>Fuel Type</b>	Gas	<b>Type of Body</b>	Sedan
<b>Colour</b>	Blue

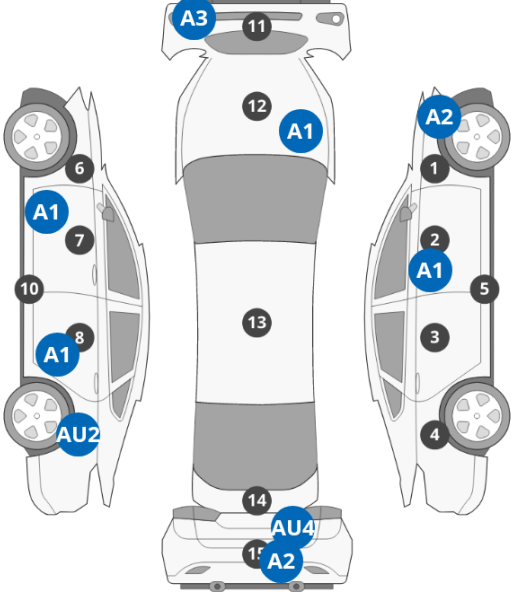
<p><b>A</b> : Scratch <b>AU</b> : Scratch &amp; Dent <b>B</b> : Modified <b>C</b> : Corrosion <b>G</b> : Stone chip <b>P</b> : Faded <b>S</b> : Rust <b>SC</b> : Rust &amp; Corrosion <b>U</b> : Dent <b>X</b> : Defective <b>Y</b> : Crack, Gap</p>
<p><b>Remarks</b> (L) Front Floor Mat - Cut, Crack - Medium / (R) Front Floor Mat - Grime - Small / (L) Front Trim - Grime - Minimal</p>	<p><b>Remarks</b> (R) Front Fender, Molding - Scratch - Small / (R) Front Door, Molding - Scratch - Minimal / Rear Bumper, Lamps, Panels - Scratch - Small / (L) Rear Fender, Molding - Scratch &amp; Dent - Small / (L) Rear Door, Molding - Scratch - Minimal / (L) Front Door, Molding - Scratch - Minimal / Front Bumper, Grille, Lamps - Scratch - Medium / Bonnet, Headlight - Scratch - Minimal / Trunk Hood, Rear Gate - Scratch &amp; Dent - Large</p>
