## General Information

Date & Time: 12, Jan, 2026 18:57

<b>Make</b>	Toyota	<b>Model</b>	Fortuner
<b>YOM</b>	2024	<b>Odo Meter Reading</b>	36,883
<b>Registration No.</b>	DBF8464	<b>Chassis No.</b>	MHFJB3GS6P1105917
<b>CC</b>	2.4	<b>Transmission</b>	A/T
<b>Fuel Type</b>	Diesel	<b>Type of Body</b>	SUV
<b>Colour</b>	Black

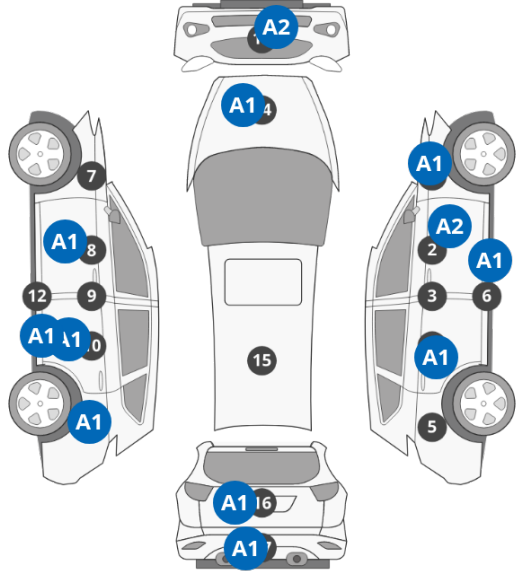
<p><b>A</b> : Scratch <b>AU</b> : Scratch &amp; Dent <b>B</b> : Modified <b>C</b> : Corrosion <b>G</b> : Stone chip <b>P</b> : Faded <b>S</b> : Rust <b>SC</b> : Rust &amp; Corrosion <b>U</b> : Dent <b>X</b> : Defective <b>Y</b> : Crack, Gap</p>
<p><b>Remarks</b> (R) Front Floor Mat - Missing - Yes / (L) Front Floor Mat - Missing - Yes / Mat Other - Missing - Yes</p>	<p><b>Remarks</b> (R) Front Fender, Molding - Scratch - Minimal / (R) Front Door, Molding - Scratch - Small / (R) Step, In-panel, Side Spoiler - Scratch - Minimal / (R) Rear Door, Molding - Scratch - Minimal / Trunk Hood, Rear Gate - Scratch - Minimal / Rear Bumper, Lamps, Panels - Scratch - Minimal / (L) Rear Fender, Molding - Scratch - Minimal / (L) Rear Door, Molding - Scratch - Minimal / (L) Step, In-panel, Side Spoiler - Scratch - Minimal / (L) Front Door, Molding - Scratch - Minimal / Front Bumper, Grille, Lamps - Scratch - Small / Bonnet, Headlight - Scratch - Minimal</p>
