General Information

Make	Toyota	Model	Vios
YOM	2025	Odo Meter Reading	22,990
Registration No.	BAG8259	Chassis No.	PA1B18F3XR4281338
CC	1.3	Transmission	CVT
Fuel Type	Gas	Type of Body	Sedan
Colour	Blue

Body / Panel Condition

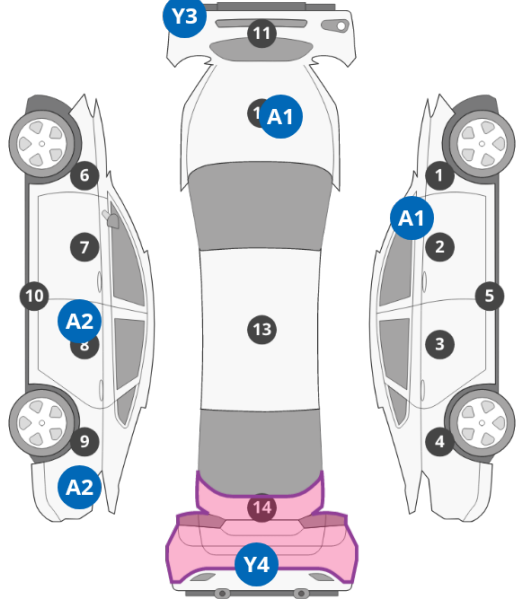
Interior Evaluation :	A	Exterior Evaluation :	C

<p>a : Cut, Fray d : Loose, Deformed k : Animal Hair s : Smell t : Cigarette Burns x : Defective y : Stain</p>		<p>A : Scratch AU : Scratch & Dent B : Modified C : Corrosion G : Stone chip P : Faded S : Rust SC : Rust & Corrosion U : Dent X : Defective Y : Crack, Gap</p>	
<p>Remarks Defects not found</p>		<p>Remarks (R) Front Door - Repair Traces - Yes / (R) Step - Repair Traces - Yes / (R) Front Fender - Repair Traces - Yes / Bonnet - Repair Traces - Yes / (L) Front Fender - Repair Traces - Yes / (L) Front Door - Repair Traces - Yes / (L) Rear Door - Repair Traces - Yes / (L) Rear Fender - Repair Traces - Yes / Trunk Hood, Rear Gate - Repair Traces - Yes / (R) Rear Fender - Repair Traces - Yes / (R) Rear Door - Repair Traces - Yes / Roof - Repair Traces - Yes / (R) Mirror - Scratch, Peeled - Minimal / Overall Exterior - Full Re-Paint in same color - Yes / Rear Bumper, Lamps, Panels - Crack, Gap - Large / Trunk Hood, Rear Gate - Repair mark - Difference in Color / (L) Rear Fender, Molding - Scratch - Small / (L) Rear Door, Molding - Scratch - Small / Front Bumper, Grille, Lamps - Crack, Gap - Medium / Bonnet, Headlight - Scratch - Minimal</p>
