## General Information

<b>Make</b>	Toyota	<b>Model</b>	Vios
<b>YOM</b>	2025	<b>Odo Meter Reading</b>	20,284
<b>Registration No.</b>	NGC9914	<b>Chassis No.</b>	PA1B18F37R4274604
<b>CC</b>	1.3	<b>Transmission</b>	CVT
<b>Fuel Type</b>	Gas	<b>Type of Body</b>	Sedan
<b>Colour</b>	Black

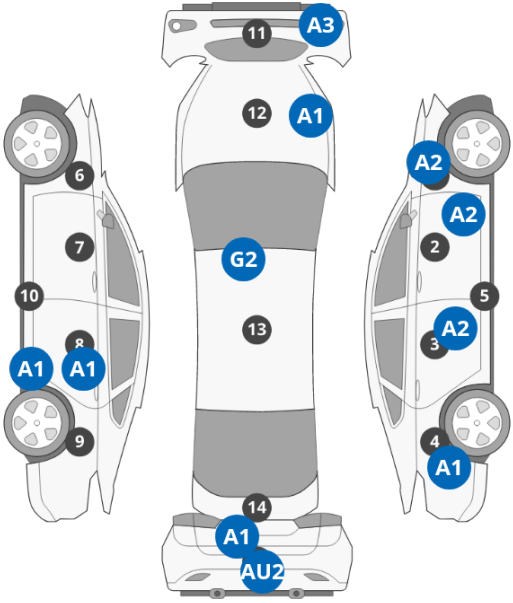
<p><b>A</b> : Scratch <b>AU</b> : Scratch &amp; Dent <b>B</b> : Modified <b>C</b> : Corrosion <b>G</b> : Stone chip <b>P</b> : Faded <b>S</b> : Rust <b>SC</b> : Rust &amp; Corrosion <b>U</b> : Dent <b>X</b> : Defective <b>Y</b> : Crack, Gap</p>
<b>Remarks</b> Defects not found	<b>Remarks</b> (L) Front Fender - Repair Traces - Yes / (L) Front Door - Repair Traces - Yes / (L) Rear Door - Repair Traces - Yes / Roof - Repair Traces - Yes / (R) Front Fender, Molding - Scratch - Small / (R) Front Door, Molding - Scratch - Small / (R) Rear Door, Molding - Scratch - Small / (R) Rear Fender, Molding - Scratch - Minimal / Rear Bumper, Lamps, Panels - Scratch & Dent - Small / Trunk Hood, Rear Gate - Scratch - Minimal / (L) Step, In-panel, Side Spoiler - Scratch - Minimal / (L) Rear Door, Molding - Scratch - Minimal / Bonnet, Headlight - Scratch - Minimal / Front Bumper, Grille, Lamps - Scratch - Medium / Front Windshield - Scratch, Stone chip - Small
