## General Information

Date & Time: 08, Jan, 2026 09:59

<b>Make</b>	Toyota	<b>Model</b>	Vios
<b>YOM</b>	2025	<b>Odo Meter Reading</b>	6,944
<b>Registration No.</b>	CCK2090	<b>Chassis No.</b>	PA1B18F37R4274585
<b>CC</b>	1.3	<b>Transmission</b>	CVT
<b>Fuel Type</b>	Gas	<b>Type of Body</b>	Sedan
<b>Colour</b>	Red

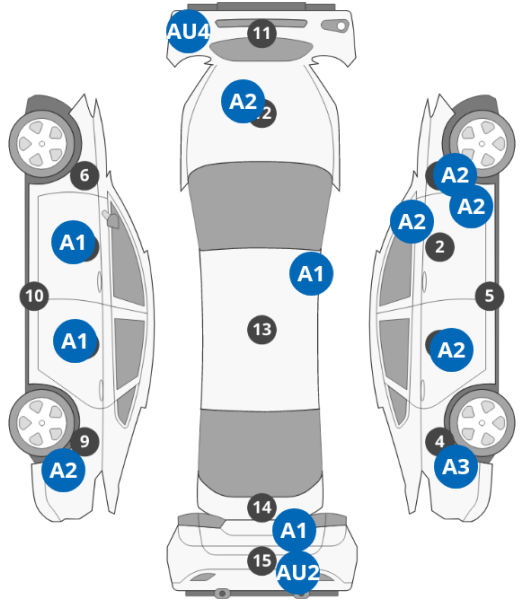
<p><b>A</b> : Scratch <b>AU</b> : Scratch &amp; Dent <b>B</b> : Modified <b>C</b> : Corrosion <b>G</b> : Stone chip <b>P</b> : Faded <b>S</b> : Rust <b>SC</b> : Rust &amp; Corrosion <b>U</b> : Dent <b>X</b> : Defective <b>Y</b> : Crack, Gap</p>
<p><b>Remarks</b> Trunk Room - Loose, Deformed - Large</p>	<p><b>Remarks</b> (R) Front Fender, Molding - Scratch - Small / (R) Mirror - Scratch - Small / (R) Front Door, Molding - Scratch - Small / (R) Rear Door, Molding - Scratch - Small / (R) Rear Fender, Molding - Scratch - Medium / Trunk Hood, Rear Gate - Scratch - Minimal / Rear Bumper, Lamps, Panels - Scratch &amp; Dent - Small / (L) Rear Fender, Molding - Scratch - Small / (L) Rear Door, Molding - Scratch - Minimal / (L) Front Door, Molding - Scratch - Minimal / Front Bumper, Grille, Lamps - Scratch &amp; Dent - Large / Bonnet, Headlight - Scratch - Small / Roof - Scratch - Minimal</p>

<p><b>Inspector Notes</b></p>
<p>With Lto plate, with warranty booklet, with jack, 3keys, no spare tire and tools, scratches on headlights and taillight</p>
