## General Information

Date & Time: 07, Jan, 2026 11:30

<b>Make</b>	Toyota	<b>Model</b>	Hilux Tamaraw
<b>YOM</b>	2025	<b>Odo Meter Reading</b>	29,501
<b>Registration No.</b>	NKN9031	<b>Chassis No.</b>	PAHACACAXS6424314
<b>CC</b>	2.4	<b>Transmission</b>	M/T
<b>Fuel Type</b>	Diesel	<b>Type of Body</b>	Utility Passenger
<b>Colour</b>	White

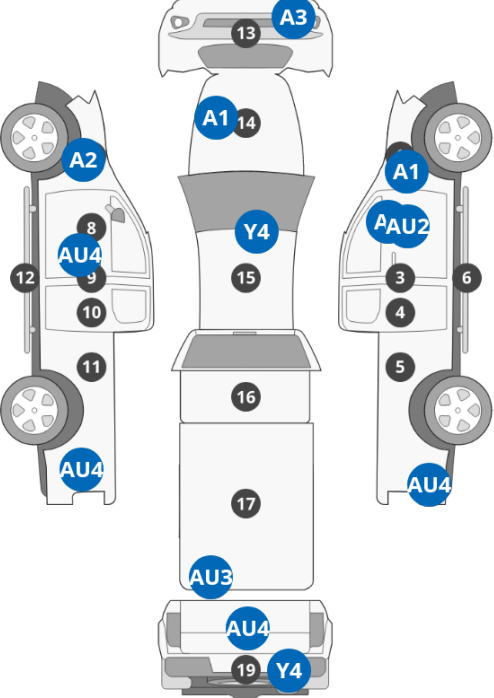
<p><b>A</b> : Scratch <b>AU</b> : Scratch &amp; Dent <b>B</b> : Modified <b>C</b> : Corrosion <b>G</b> : Stone chip <b>P</b> : Faded <b>S</b> : Rust <b>SC</b> : Rust &amp; Corrosion <b>U</b> : Dent <b>X</b> : Defective <b>Y</b> : Crack, Gap</p>
<p><b>Remarks</b> (R) Front Floor Mat - Grime - Small / Ceiling - Loose, Deformed - Large / (L) Front Floor Mat - Grime - Small</p>	<p><b>Remarks</b> (R) Front Fender, Molding - Scratch - Minimal / (R) Mirror - Scratch - Small / (R) Front Door, Molding - Scratch &amp; Dent - Small / (R) Side Gate - Scratch &amp; Dent - Large / Rear Gate - Scratch &amp; Dent - Large / Rear Bumper, Lamps, Panels - Crack, Gap - Large / (L) Front Door, Molding - Scratch &amp; Dent - Large / (L) Front Fender, Molding - Scratch - Small / Front Windshield - Damaged - Large / Roof - Scratch &amp; Dent - Medium / Bonnet, Headlight - Scratch - Minimal / Front Bumper, Grille, Lamps - Scratch - Medium / (L) Side Gate - Scratch &amp; Dent - Large</p>
