General Information

Make	Toyota	Model	Vios
YOM	2022	Odo Meter Reading	33,171
Registration No.	NID3884	Chassis No.	PA1B18F37N4181683
CC	1.3	Transmission	CVT
Fuel Type	Gas	Type of Body	Sedan
Colour	Blue

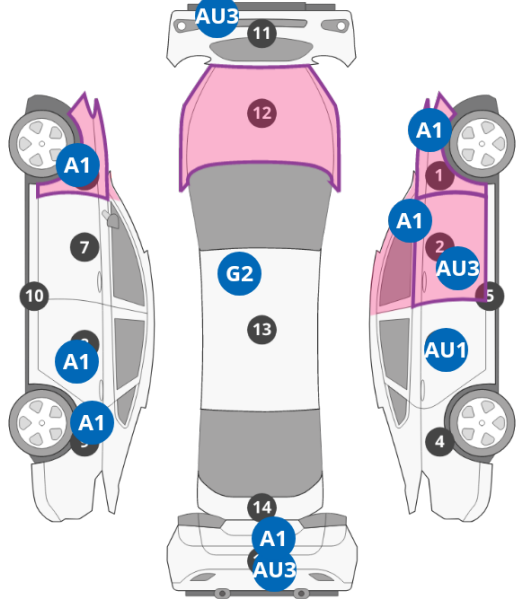
<p>A : Scratch AU : Scratch & Dent B : Modified C : Corrosion G : Stone chip P : Faded S : Rust SC : Rust & Corrosion U : Dent X : Defective Y : Crack, Gap</p>
Remarks (L) Front Floor Mat - Grime - Small	Remarks (R) Front Door - Repair Traces - Yes / (R) Front Fender - Repair Traces - Yes / Bonnet - Repair Traces - Yes / (L) Front Fender - Repair Traces - Yes / (L) Front Door - Repair Traces - Yes / (L) Rear Door - Repair Traces - Yes / (L) Rear Fender - Repair Traces - Yes / Trunk Hood, Rear Gate - Repair Traces - Yes / (R) Rear Fender - Repair Traces - Yes / (R) Rear Door - Repair Traces - Yes / Roof - Repair Traces - Yes / (R) Front Fender, Molding - Repair mark - Yes / (R) Front Fender, Molding - Scratch - Minimal / (R) Front Door, Molding - Scratch & Dent - Minimal / (R) Mirror - Scratch - Minimal / (R) Rear Door, Molding - Scratch & Dent - Minimal / Rear Bumper, Lamps, Panels - Scratch & Dent - Medium / Trunk Hood, Rear Gate - Scratch - Minimal / (L) Rear Fender, Molding - Scratch - Minimal / (L) Rear Door, Molding - Scratch - Minimal / (R) Front Door, Molding - Repair mark - Yes / (L) Front Fender, Molding - Repair mark - Yes / (L) Front Fender, Molding - Scratch - Minimal / Front Bumper, Grille, Lamps - Scratch & Dent - Medium / Front Windshield - Scratch, Stone chip - Small / Bonnet, Headlight - Repair mark - Yes
