## General Information

<b>Make</b>	Toyota	<b>Model</b>	Hilux Tamaraw
<b>YOM</b>	2025	<b>Odo Meter Reading</b>	2,726
<b>Registration No.</b>	CCQ1278	<b>Chassis No.</b>	PAHACACA3S6424025
<b>CC</b>	2.4	<b>Transmission</b>	M/T
<b>Fuel Type</b>	Diesel	<b>Type of Body</b>	Utility Passenger
<b>Colour</b>	White

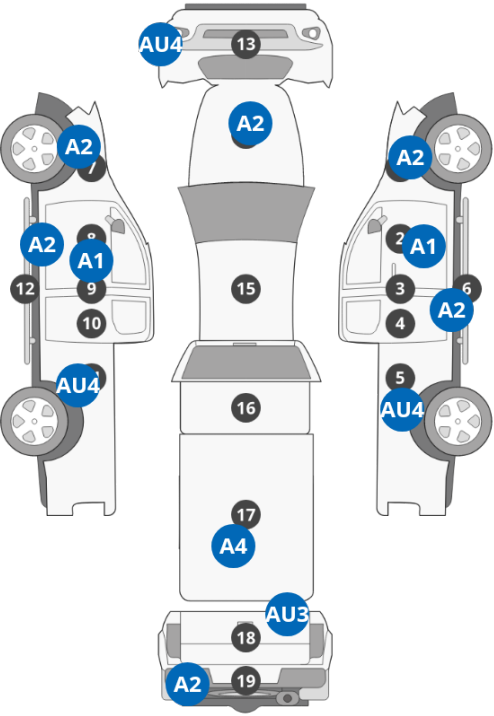
<p><b>A</b> : Scratch <b>AU</b> : Scratch &amp; Dent <b>B</b> : Modified <b>C</b> : Corrosion <b>G</b> : Stone chip <b>P</b> : Faded <b>S</b> : Rust <b>SC</b> : Rust &amp; Corrosion <b>U</b> : Dent <b>X</b> : Defective <b>Y</b> : Crack, Gap</p>
<p><b>Remarks</b> Defects not found</p>	<p><b>Remarks</b> (R) Side Gate - Scratch &amp; Dent - Large / Cargo Bed Floor - Scratch - Large / Rear Gate - Scratch &amp; Dent - Medium / Rear Bumper, Lamps, Panels - Scratch - Small / (L) Side Gate - Scratch &amp; Dent - Large / Front Bumper, Grille, Lamps - Scratch &amp; Dent - Large / (L) Front Fender, Molding - Scratch - Small / Bonnet, Headlight - Scratch - Small / (R) Front Fender, Molding - Scratch - Small / (R) Step, In-panel, Side Spoiler - Scratch - Small / (R) Front Door, Molding - Scratch - Minimal / (L) Step, In-panel, Side Spoiler - Scratch - Small / (L) Front Door, Molding - Scratch - Minimal</p>
