General Information

| Make | Toyota | Model | Vios |

Body / Panel Condition

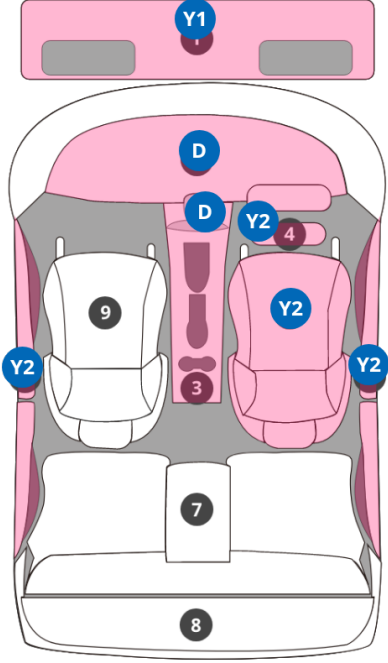
| Interior Evaluation : B | Exterior Evaluation : E |

| <p>Remarks (L) Front Trim - Grime - Small / (L) Front Floor Mat - Grime - Small / Ceiling - Grime - Minimal / (R) Front Seat - Grime - Small / (R) Front Trim - Grime - Small / Console, Switches, Vents - Traces of Adhesive Tape - Yes / Dashboard - Traces of Adhesive Tape - Yes</p> | <p>Remarks Rear Bumper, Lamps, Panels - Scratch - Medium / Trunk Hood, Rear Gate - Scratch & Dent - Small / (L) Rear Fender, Molding - Scratch - Minimal / (L) Rear Door, Molding - Scratch - Large / (L) Front Door, Molding - Scratch & Dent - Large / (L) Mirror - Scratch - Small / (L) Front Fender, Molding - Scratch - Small / Front Bumper, Grille, Lamps - Scratch & Dent - Large / (R) Front Door, Molding - Scratch & Dent - Large / (R) Rear Door, Molding - Scratch & Dent - Large / (R) Rear Fender, Molding - Scratch & Dent - Medium / (R) Front Fender, Molding - Dent - Small / Roof - Dent - Minimal</p> |
