General Information

Make	Toyota	Model	Veloz
YOM	2023	Odo Meter Reading	62,803
Registration No.	CBI5716	Chassis No.	MHFAB1BY2P3061869
CC	1.5	Transmission	CVT
Fuel Type	Gas	Type of Body	SUV
Colour	White

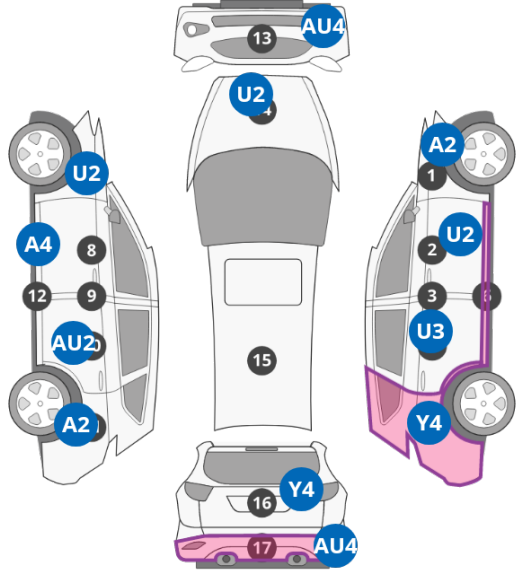
Frame Evaluation :	C	Functional Evaluation :	B
<p>Remarks Rear Side Member & Trunk Room Floor - Traces of Bending, or Marks of Panel Repair ? - Yes / Right Tyre House - Traces of Bending, or Marks of Panel Repair ? - Yes</p>		<p>Remarks Battery - Weak - Yes / Lamps (Brake, Tail, Fog) - Issue - Yes / Spare Key - Issue - Unexist</p>
