## General Information

<b>Make</b>	Toyota	<b>Model</b>	Vios
<b>YOM</b>	2024	<b>Odo Meter Reading</b>	22,180
<b>Registration No.</b>	NHR2556	<b>Chassis No.</b>	PA1B18F39P4228673
<b>CC</b>	1.3	<b>Transmission</b>	CVT
<b>Fuel Type</b>	Gas	<b>Type of Body</b>	Sedan
<b>Colour</b>	Black

## Body / Panel Condition

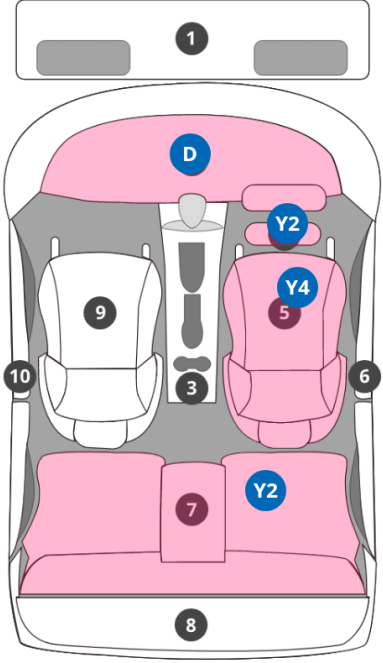
<b>Interior Evaluation :</b> <span style="float: right; color: red; font-weight: bold;">C</span>	<b>Exterior Evaluation :</b> <span style="float: right; color: red; font-weight: bold;">D</span>

<p><b>A</b> : Scratch <b>AU</b> : Scratch &amp; Dent <b>B</b> : Modified <b>C</b> : Corrosion <b>G</b> : Stone chip <b>P</b> : Faded <b>S</b> : Rust <b>SC</b> : Rust &amp; Corrosion <b>U</b> : Dent <b>X</b> : Defective <b>Y</b> : Crack, Gap</p>
<p><b>Remarks</b> (L) Front Floor Mat - Grime - Small / (R) Front Seat - Grime - Large / Rear Seat - Grime - Small / Dashboard - Traces of Adhesive Tape - Yes</p>	<p><b>Remarks</b> (R) Front Door - Repair Traces - Yes / (R) Front Fender - Repair Traces - Yes / Bonnet - Repair Traces - Yes / (L) Front Fender - Repair Traces - Yes / (L) Front Door - Repair Traces - Yes / (L) Rear Door - Repair Traces - Yes / (L) Rear Fender - Repair Traces - Yes / Trunk Hood, Rear Gate - Repair Traces - Yes / (R) Rear Fender - Repair Traces - Yes / (R) Rear Door - Repair Traces - Yes / Roof - Repair Traces - Yes / Overall Exterior - Full Re-Paint in same color - Yes / (R) Front Fender, Molding - Scratch - Minimal / (R) Front Door, Molding - Scratch - Small / (R) Rear Door, Molding - Scratch - Medium / (R) Step, In-panel, Side Spoiler - Scratch - Medium / (R) Rear Fender, Molding - Scratch &amp; Dent - Large / Rear Bumper, Lamps, Panels - Scratch &amp; Dent - Medium / Trunk Hood, Rear Gate - Scratch - Small / (L) Rear Fender, Molding - Scratch - Small / (L) Rear Door, Molding - Scratch - Minimal / (L) Step, In-panel, Side Spoiler - Scratch - Minimal / (L) Front Door, Molding - Scratch - Minimal / (L) Mirror - Scratch - Minimal / (L) Front Fender, Molding - Scratch - Minimal / Front Bumper, Grille, Lamps - Crack, Gap - Large / Bonnet, Headlight - Scratch - Small / Roof - Dent - Minimal</p>

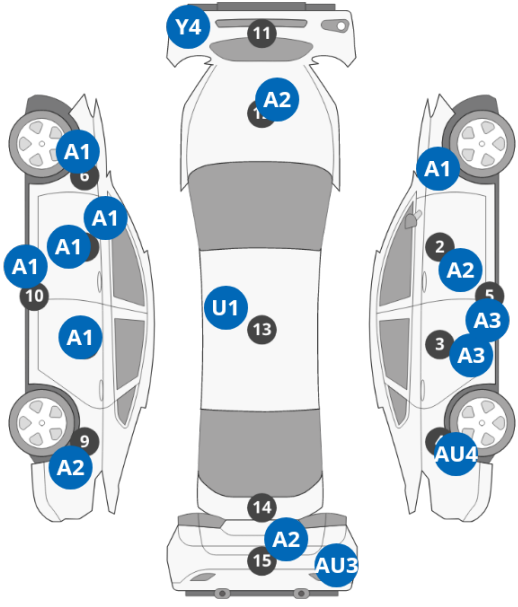
<p><b>Inspector Notes</b></p>
<p>With Lto plate, 1key, no warranty booklet, no spare tire, no jack and tools, scratches on headlights and taillights</p>
