General Information

| Make | Toyota | Model | Vios |
| Registration No. | DBR8478 | Chassis No. | PA1B18F34R4273216 |

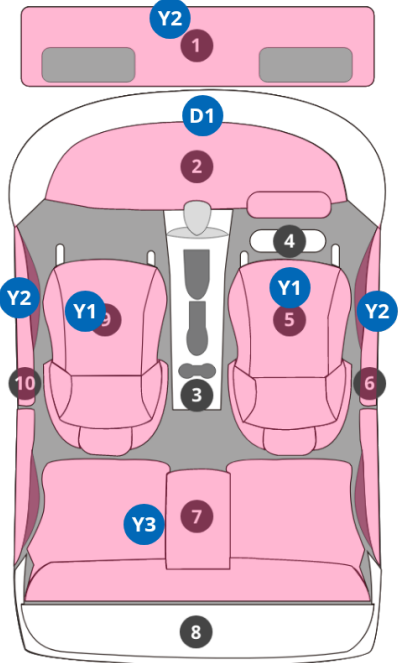
| Interior Evaluation : B | Exterior Evaluation : E |
| Remarks (R) Front Trim - Grime - Small / (L) Front Trim - Grime - Small / (L) Front Seat - Grime - Minimal / (R) Front Seat - Grime - Minimal / Dashboard - Worked - Minimal / Ceiling - Grime - Small / Rear Seat - Grime - Medium | Remarks Trunk Hood, Rear Gate - Dent - Medium / (L) Rear Fender, Molding - Scratch & Dent - Minimal / Rear Bumper, Lamps, Panels - Scratch & Dent - Medium / (R) Rear Fender, Molding - Scratch & Dent - Small / (R) Rear Door, Molding - Scratch & Dent - Small / (R) Step, In-panel, Side Spoiler - Scratch & Dent - Large / (R) Front Fender, Molding - Dent - Large / (R) Front Door, Molding - Dent - Small / Front Bumper, Grille, Lamps - Scratch - Medium / Bonnet, Headlight - Scratch - Small / (L) Front Fender, Molding - Scratch - Small / (L) Front Door, Molding - Scratch - Medium / Roof - Scratch & Dent - Small / (L) Rear Door, Molding - Scratch & Dent - Small / (L) Step, In-panel, Side Spoiler - Scratch - Minimal |
