## General Information

Date & Time: 07, Jan, 2026 08:24

<b>Make</b>	Toyota	<b>Model</b>	Vios
<b>YOM</b>	2024	<b>Odo Meter Reading</b>	22,649
<b>Registration No.</b>	NHH3780	<b>Chassis No.</b>	PA1B18F32R4257242
<b>CC</b>	1.3	<b>Transmission</b>	CVT
<b>Fuel Type</b>	Gas	<b>Type of Body</b>	Sedan
<b>Colour</b>	Blue

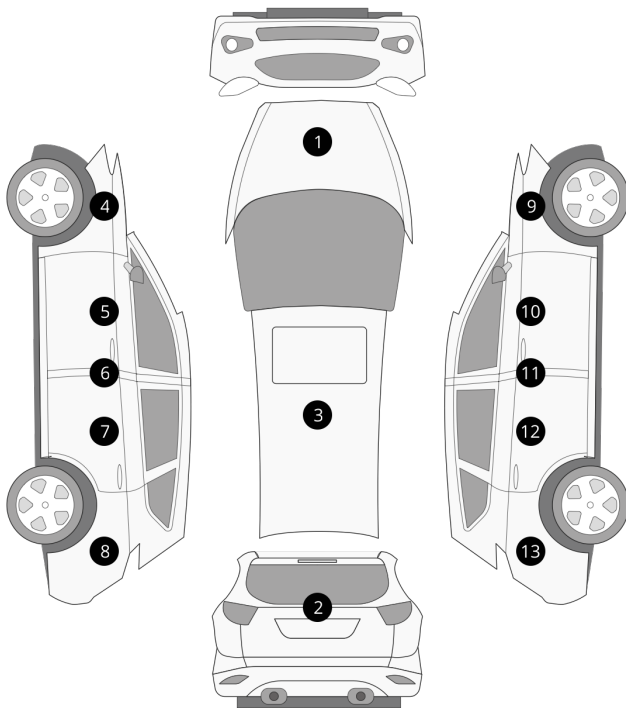
## Body / Panel Condition

#	Area	Thickness(um)			
		Average	Value1	Value2	Value3/4
1	Bonnet	108.0	129	94	101
2	Boot Lid	100.8	99	98	106
3	Roof	104.2	103	109	102/103
4	Left Front Fender	107.3	100	112	110
5	Left Front Door	100.5	99	106	96
6	Center Panel Left				
7	Left Rear Door	102.1	103	96	108
8	Left Back Panel	105.3	109	103	104
9	Right Front Fender	125.0	112	154	109
10	Right Front Door	115.0	108	128	109
11	Center Panel Right				
12	Right Rear Door	109.3	114	105	109
13	Right Back Panel	124.6	103	101	170

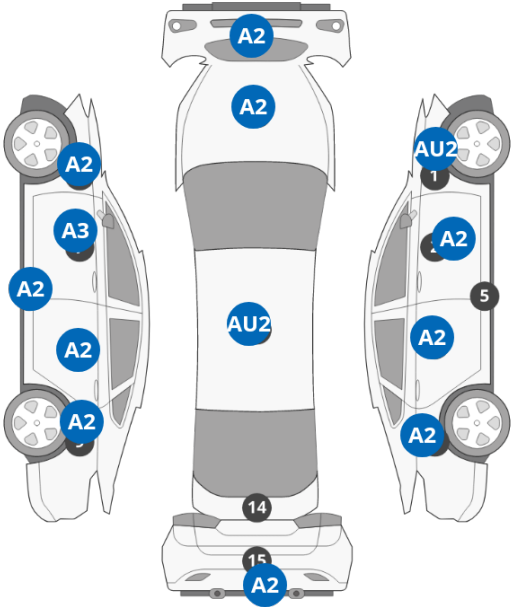
<p><b>A</b> : Scratch <b>AU</b> : Scratch &amp; Dent <b>B</b> : Modified <b>C</b> : Corrosion <b>G</b> : Stone chip <b>P</b> : Faded <b>S</b> : Rust <b>SC</b> : Rust &amp; Corrosion <b>U</b> : Dent <b>X</b> : Defective <b>Y</b> : Crack, Gap</p>
<p><b>Remarks</b> (L) Front Trim - Grime - Small / (R) Front Trim - Grime - Medium / (L) Front Seat - Grime - Small / (R) Front Seat - Grime - Small / (R) Front Floor Mat - Grime - Small / (L) Front Floor Mat - Grime - Small / Rear Seat - Grime - Small</p>	<p><b>Remarks</b> (R) Rear Fender - Repair Traces - Yes / (L) Rear Door, Molding - Scratch - Small / (L) Front Door, Molding - Scratch - Medium / (L) Front Fender, Molding - Scratch - Small / Bonnet, Headlight - Scratch - Small / Front Bumper, Grille, Lamps - Scratch - Small / (R) Front Fender, Molding - Scratch &amp; Dent - Small / Roof - Scratch &amp; Dent - Small / (R) Front Door, Molding - Scratch - Small / (R) Rear Door, Molding - Scratch - Small / (R) Rear Fender, Molding - Scratch - Small / Rear Bumper, Lamps, Panels - Scratch - Small / (L) Rear Fender, Molding - Scratch - Small</p>
