## General Information

<b>Make</b>	Toyota	<b>Model</b>	Vios
<b>YOM</b>	2025	<b>Odo Meter Reading</b>	8,727
<b>Registration No.</b>	NHS9014	<b>Chassis No.</b>	PA1B18F36R4271743
<b>CC</b>	1.3	<b>Transmission</b>	CVT
<b>Fuel Type</b>	Gas	<b>Type of Body</b>	Sedan
<b>Colour</b>	Blue

## Body / Panel Condition

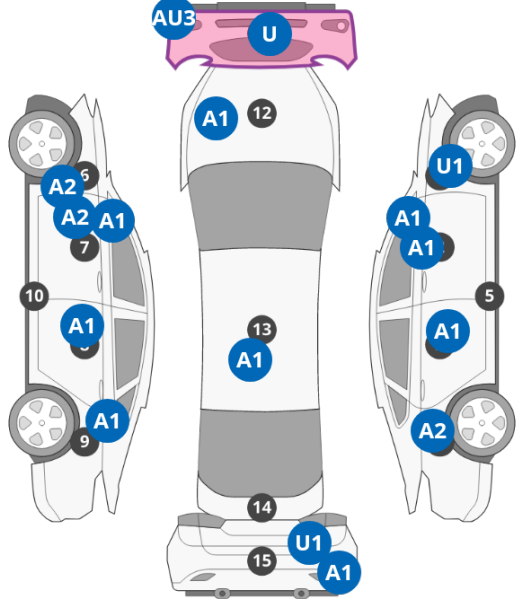
<p><b>A</b> : Scratch <b>AU</b> : Scratch &amp; Dent <b>B</b> : Modified <b>C</b> : Corrosion <b>G</b> : Stone chip <b>P</b> : Faded <b>S</b> : Rust <b>SC</b> : Rust &amp; Corrosion <b>U</b> : Dent <b>X</b> : Defective <b>Y</b> : Crack, Gap</p>
<b>Remarks</b> (L) Front Seat - Worn - Yes / (R) Front Seat - Grime - Medium	<b>Remarks</b> (R) Front Fender - Repair Traces - Yes / (R) Front Fender, Molding - Dent - Minimal / (R) Mirror - Scratch - Minimal / (R) Front Door, Molding - Scratch - Minimal / (R) Rear Door, Molding - Scratch - Minimal / (R) Rear Fender, Molding - Scratch - Small / Trunk Hood, Rear Gate - Dent - Minimal / Rear Bumper, Lamps, Panels - Scratch - Minimal / (L) Rear Fender, Molding - Scratch - Minimal / (L) Rear Door, Molding - Scratch - Minimal / (L) Front Door, Molding - Scratch - Small / (L) Mirror - Scratch - Minimal / Member (Bolted) - Dent - Yes / Front Bumper, Grille, Lamps - Repair mark - Yes / (L) Front Fender, Molding - Scratch - Small / Front Bumper, Grille, Lamps - Scratch & Dent - Medium / Bonnet, Headlight - Scratch - Minimal / Roof - Scratch - Minimal
