General Information

| Make | Toyota | Model | Vios |
| YOM | 2023 | Odo Meter Reading | 52,824 |
| Registration No. | NII5360 | Chassis No. | PA1B18F32P4202531 |

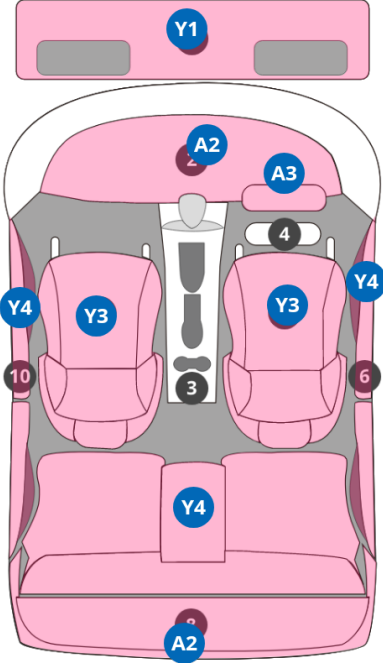
| Interior Evaluation : D | Exterior Evaluation : D |
| Remarks (R) Front Seat - Grime - Medium / (R) Front Trim - Grime - Large / Rear Seat - Grime - Large / (L) Front Seat - Grime - Medium / (L) Front Trim - Grime - Large / Steering Wheel - Worn, Peel, Crack - Medium / Ceiling - Grime - Minimal / Dashboard - Worn, Scratch, Cut, Crack - Small / Trunk Room - Worn, Scratch, Cut, Crack - Small | Remarks (R) Front Fender - Repair Traces - Yes / Bonnet - Repair Traces - Yes / (L) Front Fender - Repair Traces - Yes / (L) Front Door - Repair Traces - Yes / Front Bumper, Grille, Lamps - Scratch - Medium / (L) Front Fender, Molding - Scratch - Small / Bonnet, Headlight - Scratch - Minimal / (R) Front Fender, Molding - Crack, Gap - Medium / (R) Mirror - Scratch - Minimal / (R) Front Door, Molding - Scratch - Medium / (R) Rear Door, Molding - Scratch - Small / (R) Rear Fender, Molding - Scratch - Minimal / Rear Bumper, Lamps, Panels - Scratch - Medium / Trunk Hood, Rear Gate - Scratch - Medium / (L) Rear Fender, Molding - Scratch - Minimal / (L) Rear Door, Molding - Scratch - Medium / (L) Front Door, Molding - Scratch - Small / Roof - Scratch - Small |
