General Information

Make	Toyota	Model	Vios
YOM	2025	Odo Meter Reading	80,093
Registration No.	NKE9506	Chassis No.	PA1B18F39R4267606
CC	1.3	Transmission	CVT
Fuel Type	Gas	Type of Body	Sedan
Colour	Red

Body / Panel Condition

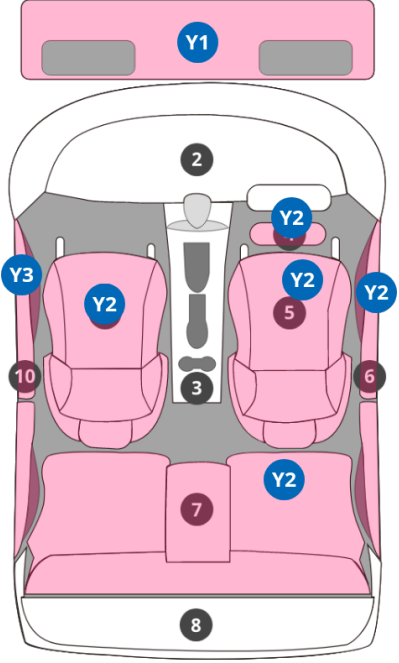
Interior Evaluation : B	Exterior Evaluation : E

<p>a : Cut, Fray d : Loose, Deformed k : Animal Hair s : Smell t : Cigarette Burns x : Defective y : Stain</p>

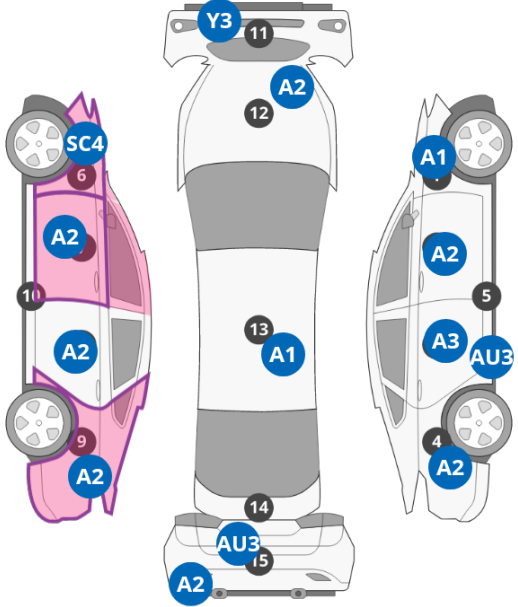
<p>A : Scratch AU : Scratch & Dent B : Modified C : Corrosion G : Stone chip P : Faded S : Rust SC : Rust & Corrosion U : Dent X : Defective Y : Crack, Gap</p>
<p>Remarks (R) Front Seat - Grime - Small / (R) Front Trim - Grime - Small / Rear Seat - Grime - Small / (L) Front Trim - Grime - Medium / (L) Front Seat - Grime - Small / (L) Front Floor Mat - Grime - Small / Ceiling - Grime - Minimal</p>	<p>Remarks (R) Front Door - Repair Traces - Yes / (R) Front Fender - Repair Traces - Yes / Bonnet - Repair Traces - Yes / (L) Front Fender - Repair Traces - Yes / (L) Front Door - Repair Traces - Yes / (L) Rear Door - Repair Traces - Yes / (L) Rear Fender - Repair Traces - Yes / Trunk Hood, Rear Gate - Repair Traces - Yes / (R) Rear Fender - Repair Traces - Yes / (R) Rear Door - Repair Traces - Yes / Roof - Repair Traces - Yes / (L) Front Fender, Molding - Repair mark - Yes / (L) Front Door, Molding - Repair mark - Yes / (L) Rear Fender, Molding - Repair mark - Yes / (L) Front Fender, Molding - Rust, Corrosion - Large / (L) Front Door, Molding - Scratch - Small / (L) Rear Door, Molding - Scratch - Small / (L) Rear Fender, Molding - Scratch - Small / Trunk Hood, Rear Gate - Scratch & Dent - Medium / Rear Bumper, Lamps, Panels - Scratch - Small / (R) Rear Fender, Molding - Scratch - Small / (R) Rear Door, Molding - Scratch - Medium / (R) Front Door, Molding - Scratch - Small / (R) Step, In-panel, Side Spoiler - Scratch & Dent - Medium / (R) Front Fender, Molding - Scratch - Minimal / Front Bumper, Grille, Lamps - Crack, Gap - Medium / Bonnet, Headlight - Scratch - Small / Roof - Scratch - Minimal</p>
