General Information

Make	Suzuki	Model	Dzire
YOM	2024	Odo Meter Reading	66,134
Registration No.	GBE2041	Chassis No.	MBHZF63S6RG506596
CC	1.2	Transmission	A/T
Fuel Type	Gas	Type of Body	Sedan
Colour	Red

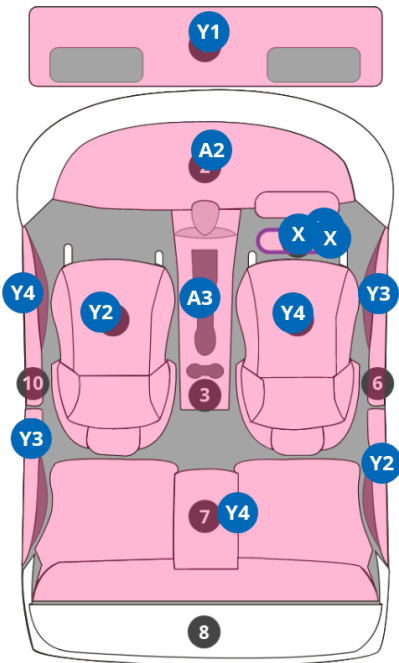
Interior Evaluation : D	Exterior Evaluation : E

<p>a : Cut, Fray d : Loose, Deformed k : Animal Hair s : Smell t : Cigarette Burns x : Defective y : Stain</p>

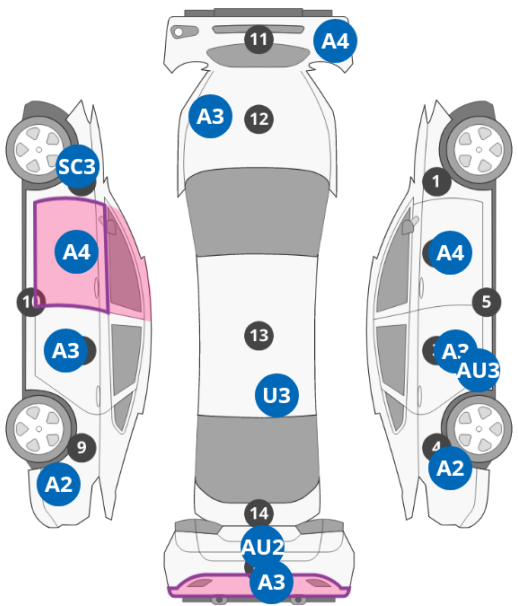
<p>A : Scratch AU : Scratch & Dent B : Modified C : Corrosion G : Stone chip P : Faded S : Rust SC : Rust & Corrosion U : Dent X : Defective Y : Crack, Gap</p>
<p>Remarks Rear Seat - Grime - Large / (R) Rear Trim - Grime - Small / (R) Front Trim - Grime - Medium / (R) Front Seat - Grime - Large / Dashboard - Worn, Scratch, Cut, Crack - Small / (L) Rear Trim - Grime - Medium / (L) Front Trim - Grime - Large / (R) Front Floor Mat - Missing - Yes / (L) Front Floor Mat - Missing - Yes / Mat Other - Missing - Yes / (L) Front Seat - Grime - Small / Console, Switches, Vents - Worn, Scratch, Cut, Crack - Medium / Ceiling - Grime - Minimal</p>	<p>Remarks (L) Front Fender - Repair Traces - Yes / (L) Front Door - Repair Traces - Yes / (L) Rear Door - Repair Traces - Yes / Rear Bumper, Lamps, Panels - Repair mark - Yes / (L) Front Door, Molding - Repair mark - Yes / (R) Front Door, Molding - Scratch - Large / (R) Rear Door, Molding - Scratch - Medium / (R) Rear Fender, Molding - Scratch - Small / Trunk Hood, Rear Gate - Scratch & Dent - Small / Rear Bumper, Lamps, Panels - Scratch - Medium / (L) Rear Fender, Molding - Scratch - Small / (L) Rear Door, Molding - Scratch - Medium / (L) Front Door, Molding - Scratch - Large / (L) Front Fender, Molding - Rust, Corrosion - Medium / Bonnet, Headlight - Scratch - Medium / Front Bumper, Grille, Lamps - Scratch - Large / Roof - Dent - Medium / (R) Step, In-panel, Side Spoiler - Scratch & Dent - Medium</p>
